Cub Crafters, Inc. Considers Compliance Mandatory

EFFECTIVE DATE: This SERVICE BULLETIN is effective April 24, 2007

SUBJECT: ACCELERATED ELEVATOR CABLE WEAR

MODELS AFFECTED: CC11-100 S/N00018, 00019, 00020, 00024 and S/N00025

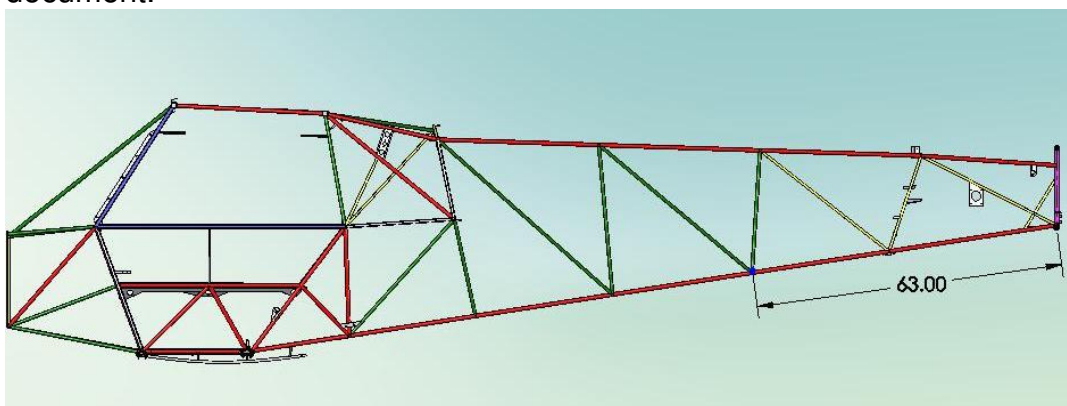
Figure 1 - Inspection Cover Location

1. Locate position 63.0" forward of rudder post on bottom side of fuselage. See Figure 1. Ensure an existing inspection cover exists. If inspection cover exists, continue to the Inspection Requirements section of this document. If no inspection cover exists, continue to the Inspection Cover Addition Procedure options A or B section of this document.

1. Mark a position (inbd/outbd) between bottom stringer and fuselage at 63" forward of rudder post.
2. Scuff a 6.5" diameter section around marked position using 220 grit sandpaper. Scuffing must be deep enough to see silver of fabric.

1. Mark a position (inbd/outbd) between bottom stringer and fuselage at 63" forward of rudder post.
2. Center TC3017-001 Grommet on marked location. Poly-Tak TC3017-001 Grommet to fabric. Clean up any Poly-Tak drips using MEK.
3. Allow Poly-Tak to dry.

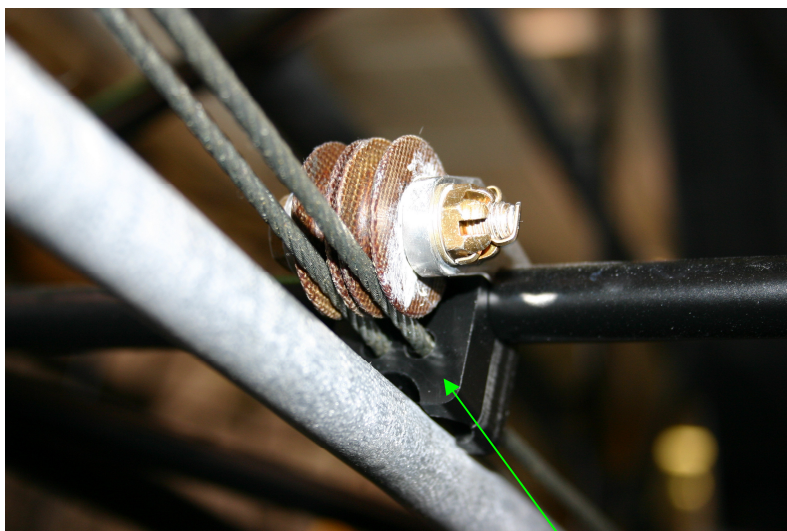
Suspect Fairlead

PURPOSE: A BATCH OF CABLE FAIRLEADS HAVE BEEN IDENTIFIED THAT MAY LEAD TO ACCELERATED ELEVATOR CABLE WEAR. AN INSPECTION COVER NEEDS TO BE ADDED TO ALLOW ACCESS TO CHECK ELEVATOR CABLE FOR UNDESIRABLE WEAR.

1. Cable going through suspect fairlead must be inspected every 10 hours for the first fifty (50) flight hours. If no discrepancies are found, continue to Step 2. If any discrepancies found, see Step 7 in Inspection Procedure.

1. Remove TC9101-001 inspection cover.
2. Move control stick to full forward position (elevator full down).
3. Inspect cable around fairlead for any unusual wear.
4. Move control stick to full aft position (elevator full up).
5. Inspect cable around fairlead for any unusual wear.
6. Replace TC9101-001 Inspection Cover.
7. If any discrepancies found, Contact Cub Crafters, Inc. prior to next flight.
