**Cub Crafters, Inc. Considers Compliance Mandatory**

**EFFECTIVE DATE:** This SERVICE BULLETIN is effective June 1, 2007

**SUBJECT:** UN-COMMANDED FLAP RETRACTION

**MODELS AFFECTED:** CC11-100 S/N00002 thru S/N00031

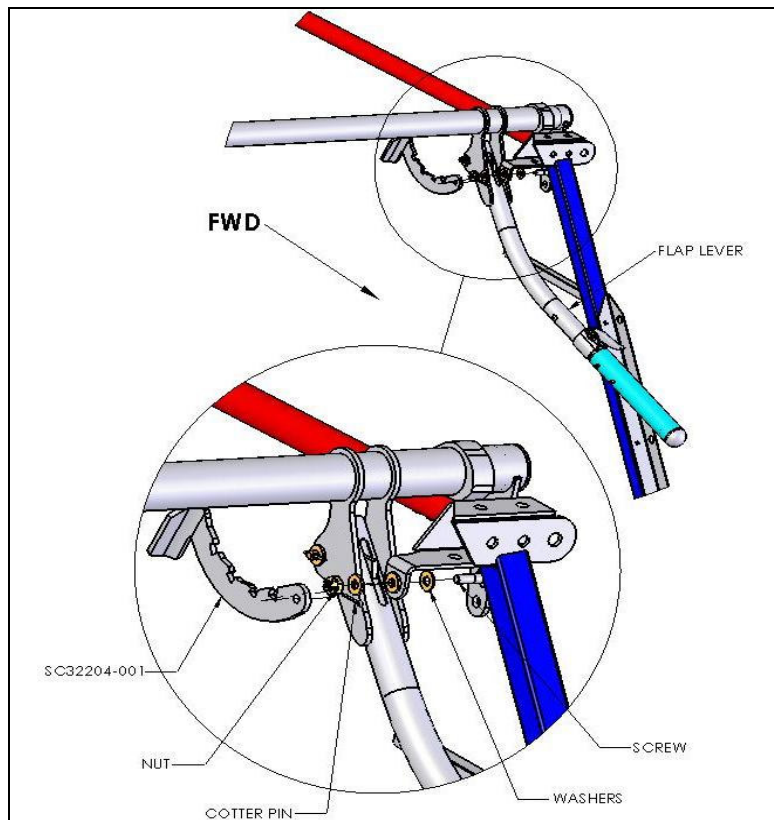
**Figure 1**

**PURPOSE:** THE FLAP LOCKING MECHANISM HAS THE POSSIBILITY OF DISENGAGING CAUSING UN-COMMANDED FLAP RETRACTION.

1. Remove existing SC32204-001 by removing hardware as shown in Figure 1. Retain hardware and discard SC32204-001 and cotter pin.
2. Rotate flap lever arm fore and aft while applying pressure inboard or outboard to center and align flap cross bar with fuselage centerline as necessary.
3. Install SC32204-001 Revision F using same hardware and new cotter pin (AN380-2-2). SC32204-001 should be centered thru flap lever slot (see Figure 2). Additional washers (AN960-10 or AN960-10L) may be used to shim SC32204-001 to achieve center position. Do not use more than 4 washers per side to shim.
