SERVICE BULLETIN
NO.: 0921 Rev A

TO: All Garmin Aviation Service Centers
DATE: June 22, 2009
SUBJECT: SL30, SL40, GNS 480(CNX80) Comm Radio Spurious Emissions

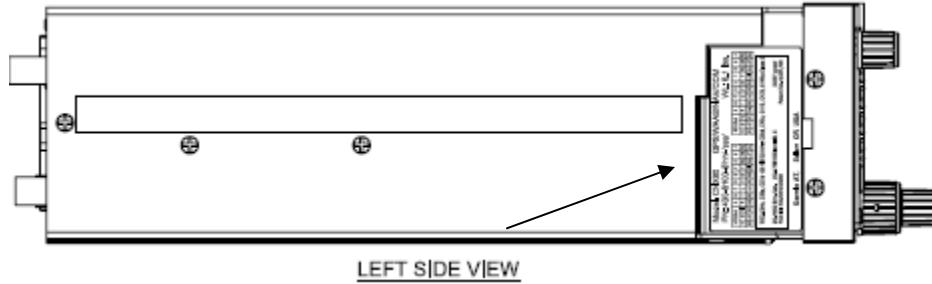
To identify the mod level of a GNS 480 (CNX80) unit:

Remove the unit and locate the nameplate on the left side of the unit. The hardware mod status is indicated in the block on the left side of the nameplate.

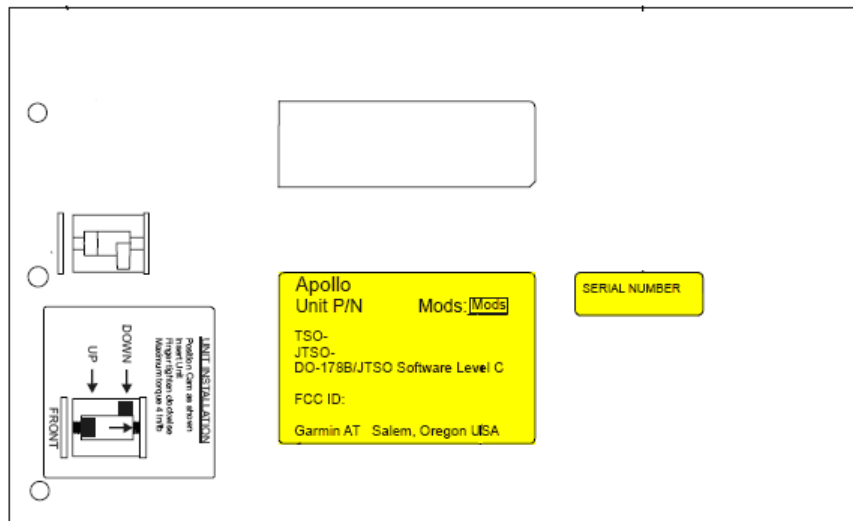
To identify the mod level of an SL30 or SL40 unit:

Remove the unit from the aircraft and locate the nameplate on the bottom side of the unit.
