SERVICE INSTRUCTION SK-SI001 Rev NC Page 1 of 2

SUBJECT: PROPELLER LEVER SPRING RETROFIT INSTRUCTIONS

MODELS AFFECTED: CCK-2000 AND CCX-2000 S/N 0001 THROUGH 0072

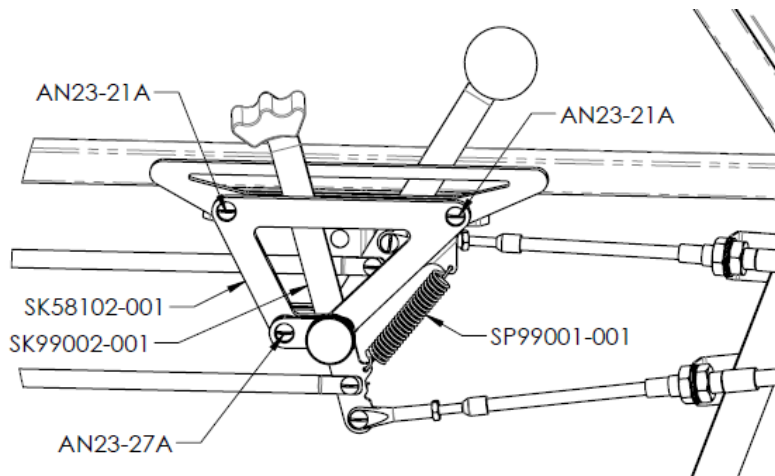
Figure 1 – Replacement Components Installed

PURPOSE: This document provides instructions for the modification of the engine controls to add an extension spring between the propeller lever and the spacer block. Incorporation of this modification may improve control ergonomics, preventing prop lever creep and/or stiff engine controls.

- c. Verify that the propeller lever does not spring forward when the lever is pulled to the aft position. If there is a tendency of the lever to spring forward, the friction in the system may need to be increased by tightening the bolts that mount the control assembly. In particular, tightening the AN23-27A bolt noted in Figure 1, will increase the friction in the system.

1. Read all instructions before beginning any work.
2. Remove the left center interior panel. (AMM Chapter 25-00)
3. Disassemble the forward controls in order to remove the forward propeller lever (XC99002-001) and spacer block (SC58102-004). (AMM Chapter 76-00)
4. Reassemble the forward controls with the replacement parts. Replace the propeller lever with SK99002-001, and replace the spacer block with SK58102-001. Add an extension spring (SP99001-001) between the spacer block and the prop lever as shown in Figure 1.

- b. Verify that the throttle and propeller levers do not hit the interior panel or the AN23-21A bolts in the control assembly (see Figure 1). The movement of the throttle and propeller levers should be limited by the mechanical stops firewall forward, not the interior panel or control assembly bolts.
