SERVICE INSTRUCTION **XK-SI001** Rev NC Page 1 of 7

SUBJECT: *COWL FITMENT WEAR PREVENTION*

MODELS AFFECTED: *CCX-2300 S/N 0001 THROUGH 0015*

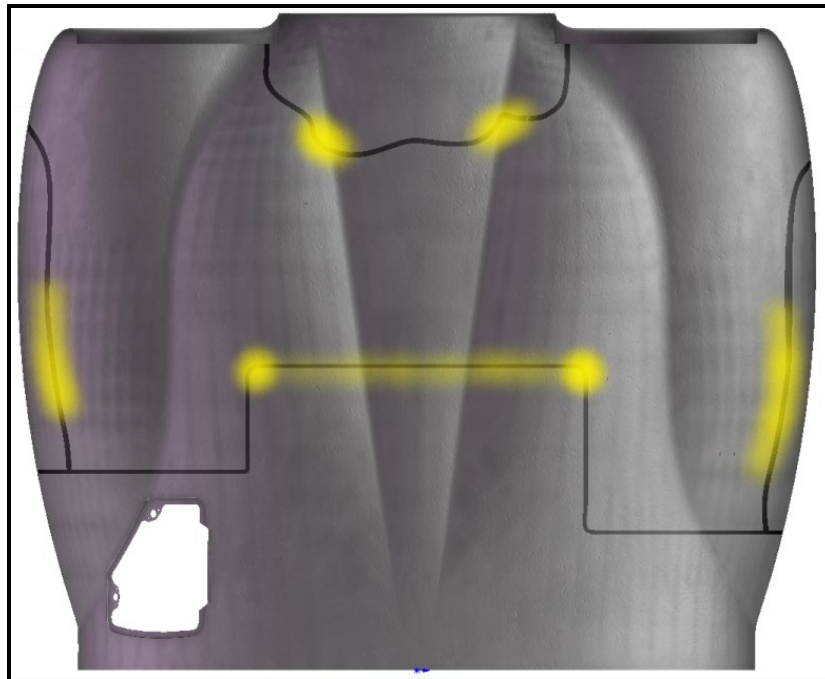
Figure 3 - Upper Cowl Possible Chafing Locations

4. *Steps 5-9 are each subject to inspection results and the discretion of the owner/operator. Some, all, or none of the zones described may exhibit wear from inadvertent component contact. If no signs of excess wear are present on any cowl panels, proceed directly to Step 10.*
5. Locate and mark all zones where direct composite to composite or fastener to composite contact is in evidence. Figure 3 depicts possible contact zones on underside of the upper cowl.
