SERVICE BULLETIN SK-SB011

SUBJECT: INSPECTION & TIGHTENING OF BERINGER MASTER CYLINDER JAM NUTS

MODELS AFFECTED: CCX-2000-0001 and on; if Beringer brakes are installed.

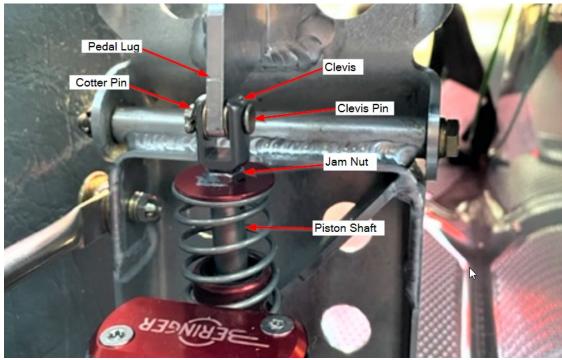
Figure 1

master cylinders have not been adequately tightened.

1. With a 10MM and a 9MM box end wrench, check to verify that the jam nut of the master cylinder (located on the forward side of the aft brake/rudder pedal) is tight. The 10MM wrench will fit the jam nut, and the 9MM wrench fits the flats of the piston shaft. If the nut is tight, make a logbook entry stating that the jam nut was checked and verified to be tight in accordance with this Service Letter. If the nut is loose, proceed to the next steps.

- 2. Chock wheels and release parking brakes.
- 3. Remove the cotter pin and clevis pin that attach the clevis to the pedal lug (reference Figure 1) and allow the disconnected master cylinder to pivot forward.
- 4. This step may take place with the master cylinder still attached to the lower mount, or it may be removed for easier access. Measure the distance between the lower mount hole and the clevis hole. Adjust the clevis as necessary to set this distance to 5.29". Tighten the jam nut against the piston shaft. The piston shaft has flats that can be used to prevent the shaft from rotating while the jam nut is tightened.
