SERVICE INSTRUCTION CK-SI005 Rev NC Page 1 of 7

SUBJECT: FUSELAGE TUBE REPAIR

MODELS AFFECTED: CCK-1865-0001 and on, CCX-1865-0001 and on

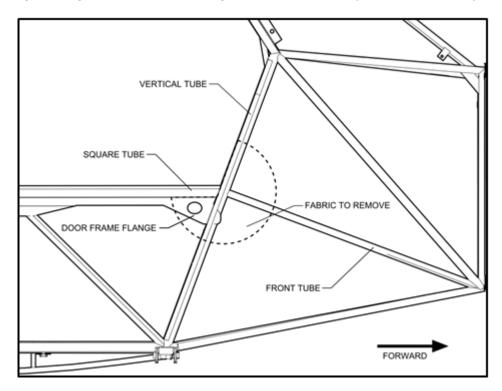
Figure 1 - Fabric Cutout, View From Right Side

- 3. Place the aircraft in a level attitude, ref CK10000AMM chapter 08.
- **4.** In order to access the work area, cut and remove the fabric section shown in Figure 1. The section should be large enough to access the tubing several inches away from the broken junction.

- 22. The section of fabric removed in step 1 should be patched per the Polyfiber manual.
- 23. Attach the right side window and main door reversing the removal procedure.
