SENENICH PROPELLER CO., INC.

SERVICE BULLETIN SB2019-02A

SUBJECT: Inspection of adjustable pitch hubs for cracks

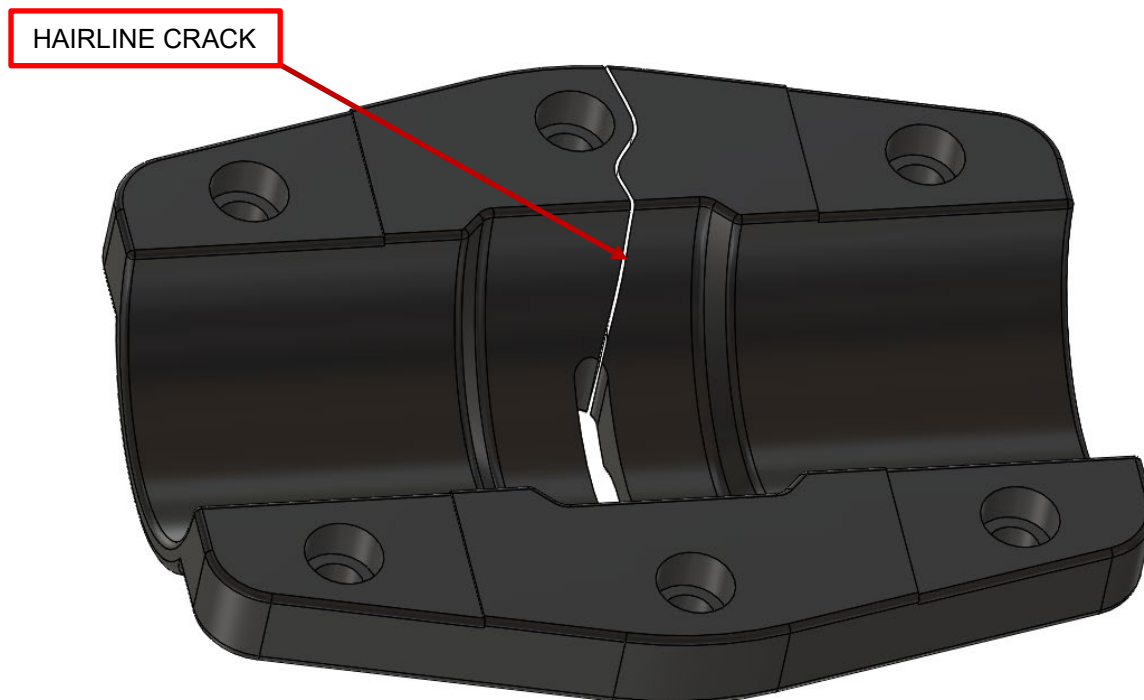
- The hub cracks typically start at or near the pitch cartridge slot on the sides of the central hole, and grow outwards towards the hub sides. They are hairline cracks which are very difficult to see with the naked eye. Refer to Figures 1 & 2 for crack location.

Figure 1. Cracks start near pitch marks and grow outwards.

- Using very good lighting and a 10x magnifying glass, inspect the inside of the pitch cartridge slot in the hub cover next to the pitch marks.
- The hub cover must be removed from the propeller assembly for thorough inspection inside the pitch cartridge slot. *Inspection of the hub exterior is not adequate.*

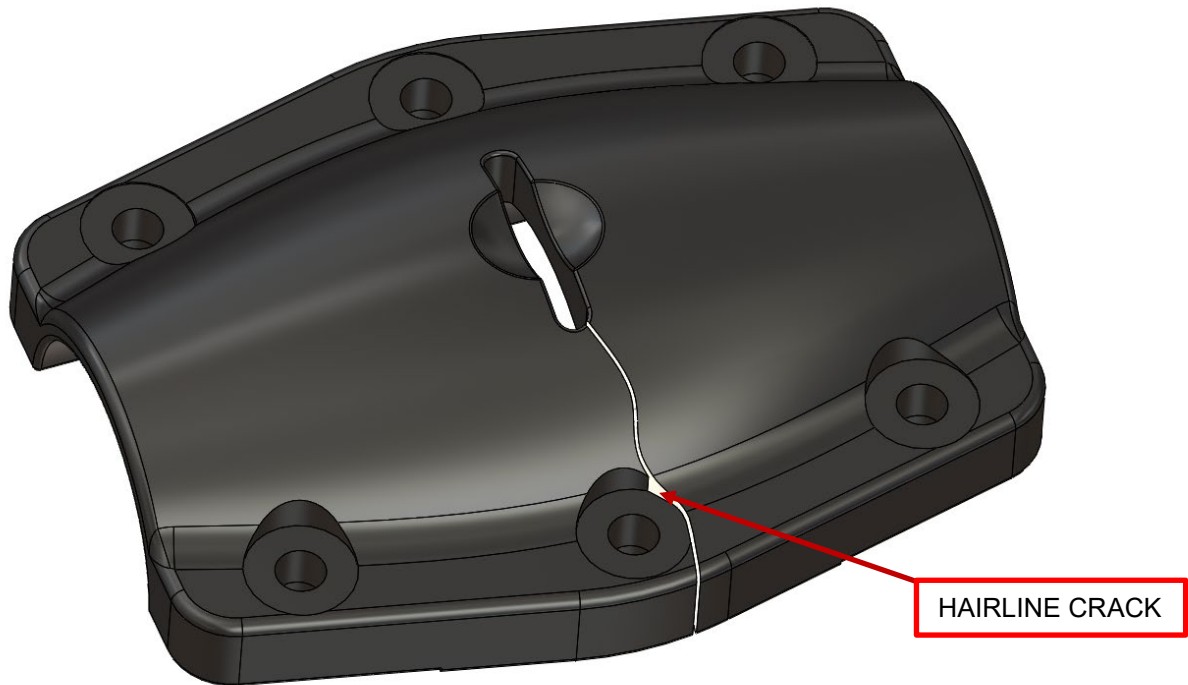
- The occurrence, if unattended, could result in the hub cover half cracking completely across.
- To date, there have been no inflight blade separations but the location of crack growth necessitates immediate inspection.

Figure 2. Unattended cracks may progress to edges of hub cover half.

- Notify Sensenich of any crack occurrences and return affected hub for evaluation.
- Inspect affected hub for cracks every 50 hours or annually, whichever comes first.
