NB00006

EFFECTIVE DATE:	This NOTIFICATION is effective May 19, 2023
SUBJECT:	Oil Filter Defect
APPLICABLE MODELS:	CC11-100 Aircraft
COMPLIANCE TIME:	As Required
PURPOSE:	Cub Crafters has been made aware of a single installation where the threads of the oil filter were not normal to the sealing face. This defect from the manufacturer can result in an uneven and unreliable seal. This notification is to inform owners of the potential issue and provide instructions to verify a proper installation on their aircraft.

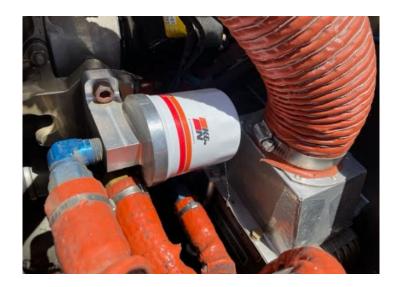
1. Remove upper cowl to verify if an oil filter is installed, as not all CC11-100's are equipped with this filter. It will be located on the aft side of the engine on the left side.

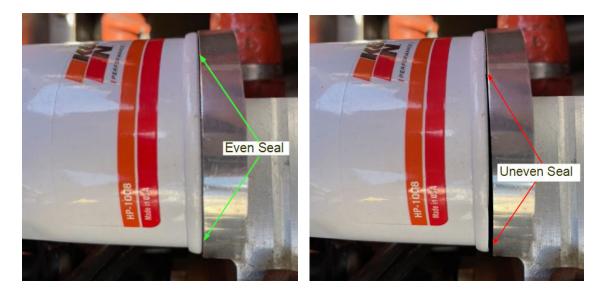
- **2.** If you have no oil filter here, then this notification is not applicable to your aircraft and the upper cowl may be reinstalled.
- **3.** If you do have an oil filter here, inspect the interface between the filter and filter adapter. The interface should be consistent and even around the entire perimeter.

If the perimeter does not have an even seal, your oil filter must be replaced with a new SP56002-002 filter before next flight. You can order a replacement filter <u>online</u>, or contact the Cub Crafters store.
