Cub Crafters, Inc. Considers Compliance Mandatory

EFFECTIVE DATE: 05/10/2023

SUBJECT: *LANDING GEAR ATTACH BRACKET INSPECTION*

MODELS AFFECTED: CCX-2300-0001 through CCX-2300-0062; if bungee gear is installed.

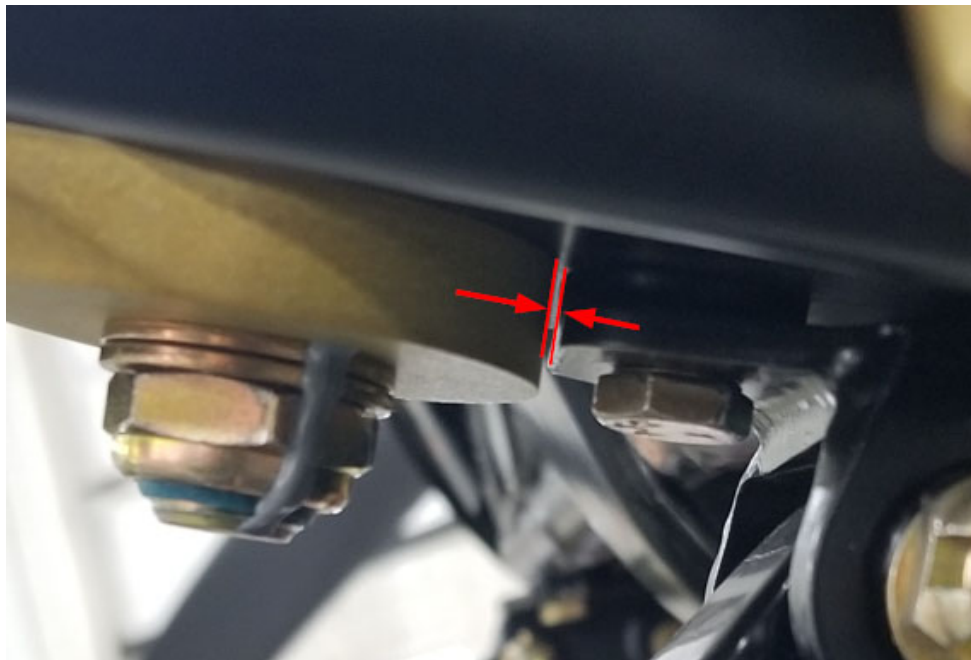
PURPOSE: *Cub Crafters has been made aware of an instance where the aft gear to fuselage attach bracket's weld bead contacted the lower fitting of the wing lift strut.*

1. Remove left and right aft fairing sets from around the gear and lift strut attachment.
2. On the bottom side of the joint, look for clearance. Any amount of clearance is sufficient. If there is clearance, skip to step 5.

Figure 1 – Clearance between Fittings

3. If no clearance is found, contact customer service for a new set of landing gear brackets, XC41060-001 and XC41060-002.
4. Replace landing gear fittings per XK10000AMM section 32-10.
