SERVICE INSTRUCTION **SI0040** Rev NC **Page 1 of 6**

SUBJECT: *REPLACEMENT OF WIG-WAG FLASHER SP74005-001, SC73107-001, AND ALL SC73106 PRIOR TO REVISION D.*

MODELS AFFECTED: *CC11-100 AND CC11-160 SN 00107 to 00441
CCK/CCX-1865 PRIOR TO 0039
CCK/CCX-2000 PRIOR TO 0179*

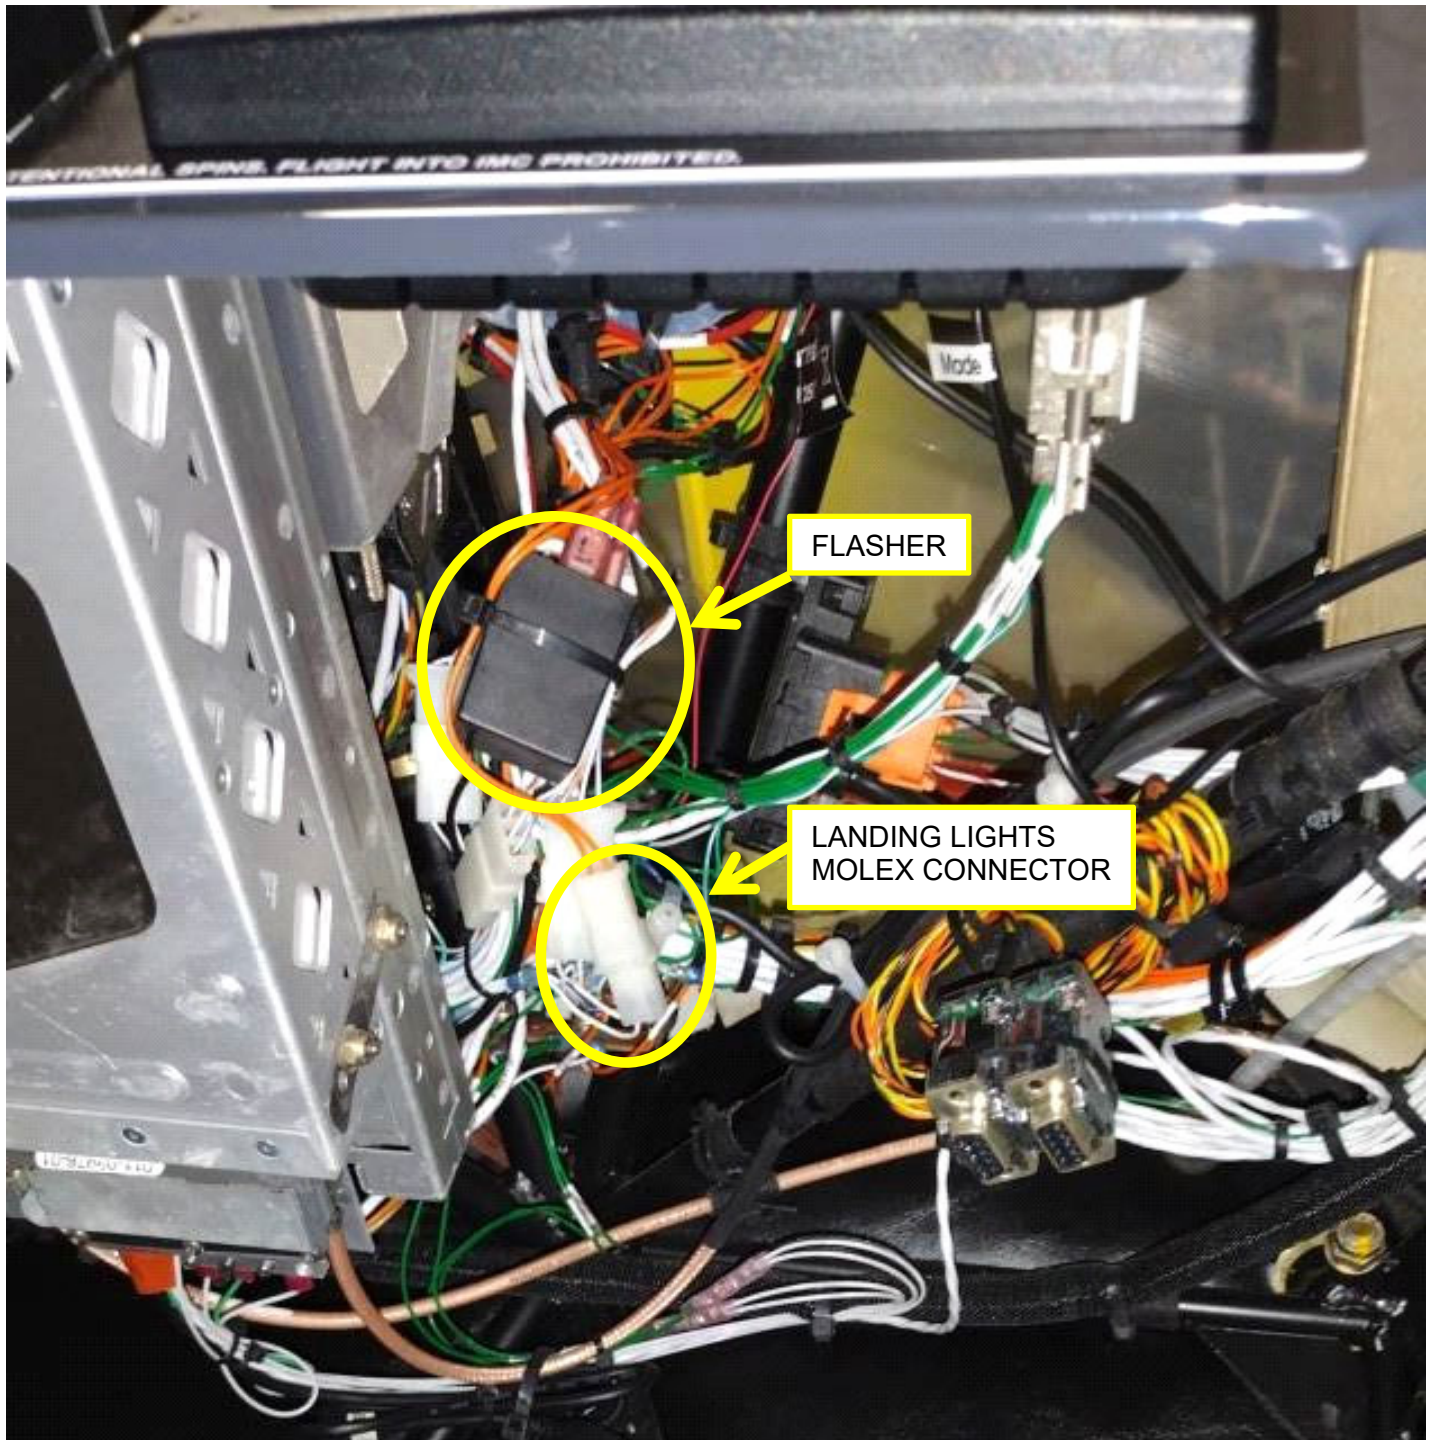
Figure 1: Behind Instrument Panel - First Gen Flasher

1. Read all instructions before beginning any work.
2. All work will be accomplished behind the instrument panel.
3. Locate landing light switch and unbundle the wires and flasher devices between the switch and the 2-pin molex connector to wires LB01A20W-1 and LB14A20W-1.
