SERVICE BULLETIN CK-SB011

EFFECTIVE DATE:	This service bulletin is effective July 17, 2025 .
SUBJECT:	<i>BUNGEE & ROTAX EXHAUST POSITION INSPECTION</i>
MODELS AFFECTED:	CCX-1865-1001 and on, only if bungees are installed
COMPLIANCE TIME:	Within 5 flight hours or when bungees are installed
PURPOSE:	To ensure that the bungees are undamaged, and that the exhaust tailpipe is clamped in a specific position.
INSPECTION:	Steps 1 through 5 should be repeated every 25 flight hours until canceled by superseding service action.
WARRANTY:	Aircraft under warranty will receive up to 0.5 hours of labor cost for inspection and up to 3 hours of labor cost if adjustment work is performed at a Cub Crafters Authorized Service Center. Please contact Cub Crafters Customer Support for assistance.

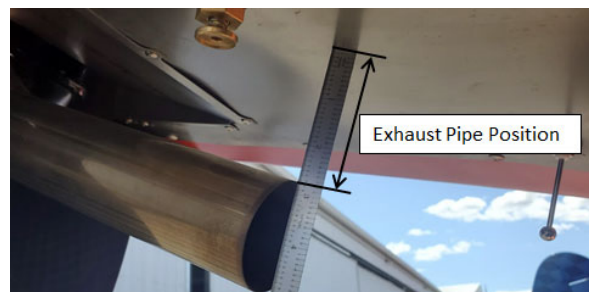
Figure 1 – Measurement of Exhaust Pipe Position

7. Measure the distance between the upper edge of the aft end of the exhaust pipe and the titanium belly of the boot cowl. This distance will be referred to as the "exhaust pipe position". See Figure 1.

- a. If the exhaust pipe position is less than 2.25" (57mm), inspect the aircraft belly aft of the exhaust for any signs of exhaust damage. If belly damage is found, contact Cub Crafters for next steps.
 - b. If the exhaust pipe position is between 2.25"-2.75" (57mm-70mm):
 - i. and premature bungee damage was found in step 3, contact Cub Crafters for next steps.
 - ii. and no bungee damage was suspected or found in step 3, skip to step 13.
8. Remove the cowling per the AMM. (It is acceptable to leave the cowling in place if the nut and 3 screws in the following step can be reached through the cowl vent.) See Figure 2.

9. Loosen the 10mm nut on the V-clamp securing the exhaust pipe to the muffler, as well as the M5x12 Torx bit set screws (3) in the muffler housing.
10. Adjust the exhaust pipe position to between 2.25"-2.75" (57mm-70mm), measured per Figure 1.
11. Re-tighten the V-clamp via the 10mm nut. Torque nut to 70 in-lb (8 Nm) per MMH-916i A/C24 Chapter 78-10-00 pg. 12, step 5. Torque M5x12 Torx set screws (3) to 44 in-lbs (5 Nm) per MMH-916 A/C24 Chapter 78-10-00 pg. 12, step 6.
12. Re-install the cowling (if removed) per the AMM.
13. Make a log book entry "Complied with CK-SB011 Rev NC"
