SERVICE BULLETIN XK-SB004 Rev NC Page 1 of 4

SUBJECT: *ALTERNATOR OUTPUT STUD HARDWARE INSPECTION*

MODELS AFFECTED: CCX-2300-0070 through CCX-2300-0110, CCX-2300-0112, CCX-2300-0113

PURPOSE: *Cub Crafters has been made aware of an instance where incorrect hardware was found installed on "B" terminal of the alternator after experiencing COM noise and charging issues.*

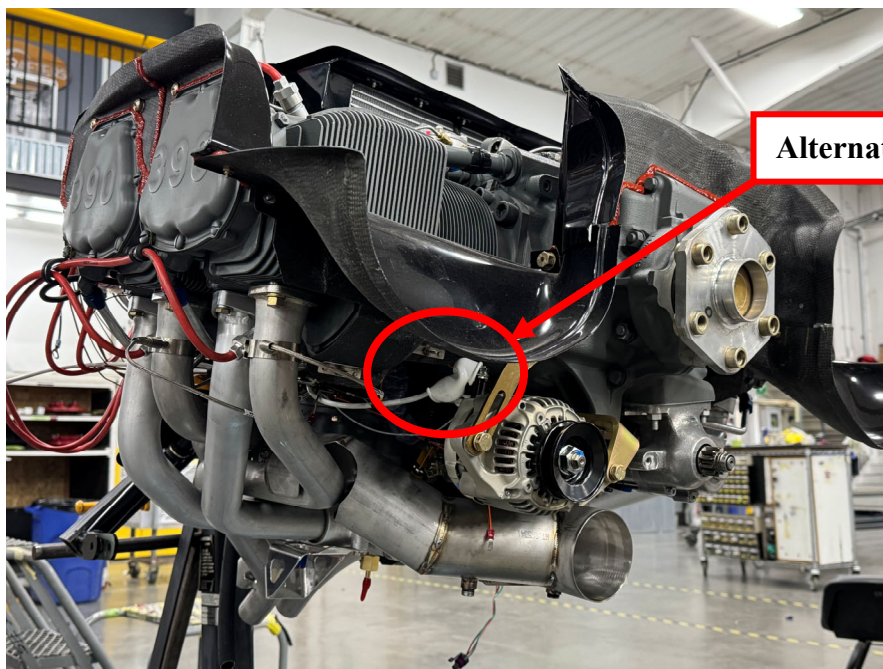
Figure 1: Under Engine, Looking up

1. Read all instructions before beginning any work.
2. Remove cowling, retaining all fasteners.
3. Locate the "B" terminal of the alternator (see Figure 1).

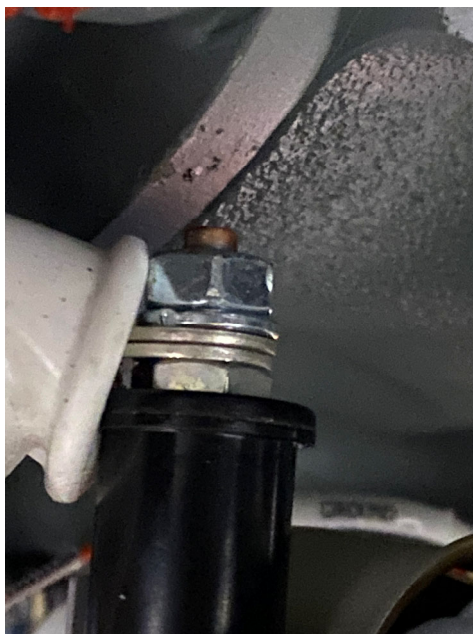
Figure 2: Example of correct hardware

4. Inspect the nut type and condition of the terminal stud.
 - a. If the hardware is correct (see Figure 2), then refer to Finishing Steps.

1. Refer to parts list under QTY A.
2. Replace hardware with the correct nut; VP6408-021 and correct washer; VP6408-023 (see Figure 2).

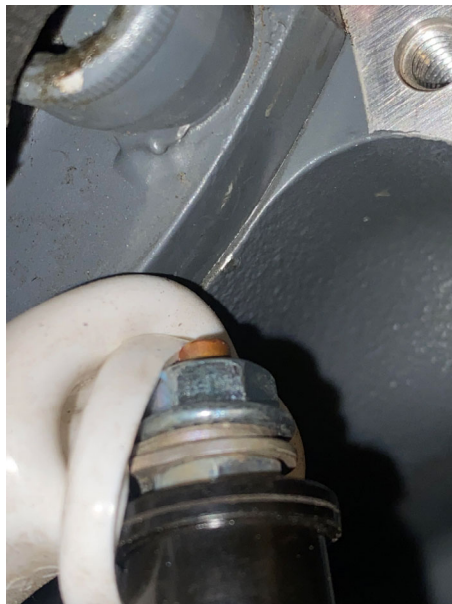
- b. If the hardware is incorrect, but tight, and undamaged (see Figure 3), then refer to Section A.

Figure 3: Example of incorrect hardware that is tight and undamaged

Section A – Hardware Terminal Replacement

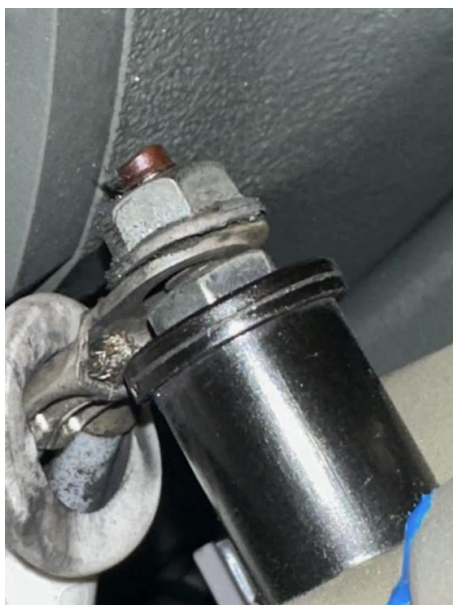
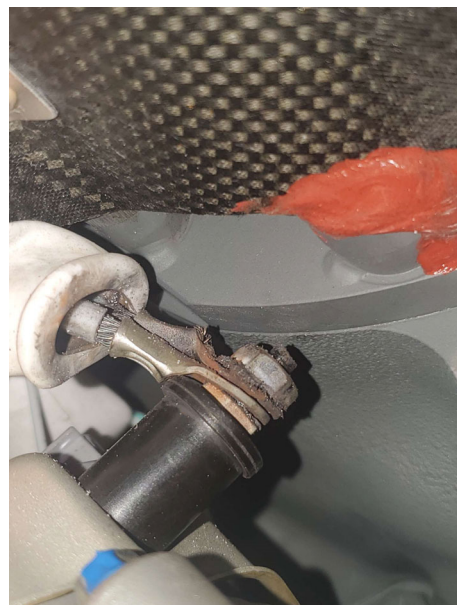
- c. If the hardware is incorrect, and has visible play on stud or has thermal or corrosion damage (see Figure 4), then refer to Section B.

Figure 4: Examples of visible play on stud and thermal/corrosion damaged hardware

Section B – Alternator Replacement

1. Refer to parts list under QTY B.
2. Remove the alternator as per the Aircraft Maintenance Manual (No. XK10000AMM) § 24-00.3.A.1.
3. Replace with a new alternator (VP6408-001), using the new MS21045-6 nut for the pivot bolt.
4. Reinstall the alternator as per the Aircraft Maintenance Manual (No. XK10000AMM) § 24-00.3.A.3.
5. Reconnect “B” terminal hardware with the correct nut; VP6408-021 and the correct washer; VP6408-023 (see Figure 2).
