HARTZELL PROPELLER LLC
ALERT SERVICE BULLETIN
HC-ASB-61-410
A-2044 Self-Locking Hex Nut, 1/2-20

HC-ASB-61-410

A-2044 Self-Locking Hex Nut, 1/2-20

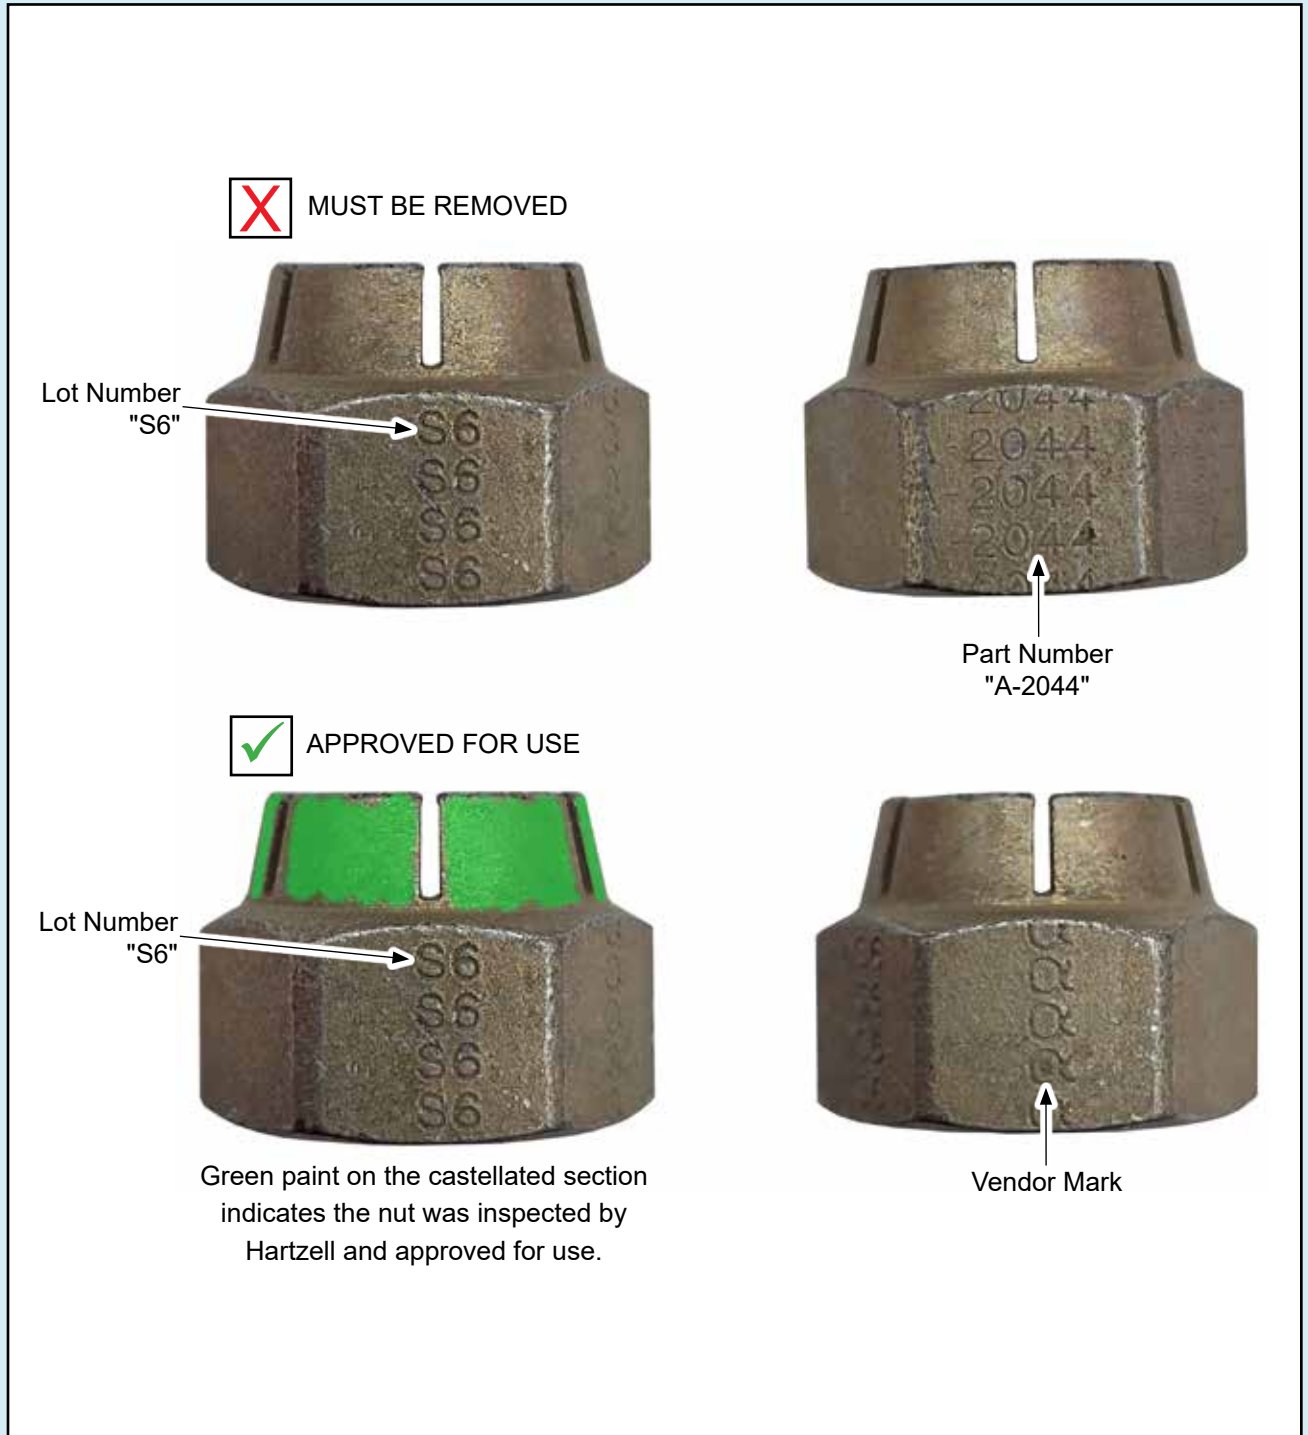
**Affected A-2044 Hex Nut Identification
Figure 1**

- (a) Affected A-2044 hex nuts will be marked with lot number "S6" and the vendor mark shown in Figure 1.
- (3) Hartzell Propeller overhaul kits listed in Table 1 that were shipped from Hartzell between December 8, 2025 and February 4, 2026 are affected by this Alert Service Bulletin.

- (1) Hartzell Propeller received a shipment of A-2044 self-locking hex nuts that were manufactured incorrectly. The locking feature on the nuts in the affected lot is defective and can loosen during flight.
 - (a) The A-2044 hex nuts are shipped loose with affected propellers and are used to mount the propeller on the aircraft.

NOTE: If the castellated section of an A-2044 hex nut marked "S6" is painted green as shown in Figure 1, the nut was inspected by Hartzell and approved for use. Painted nuts can be returned to inventory/stock.

- (a) A-2044 hex nuts marked with lot number "S6" but not painted green must be removed from inventory and returned to Hartzell.

- (b) For A-2044 hex nuts marked with lot number "S6" but not painted green, perform the following steps before further flight:
 - 1 Remove and discard the affected A-2044 hex nut.
 - 2 Install a new, non-affected A-2044 hex nut, then torque the nut in accordance with the applicable Hartzell Propeller owner's manual.
 - 3 Complete and sign the Parts Order/Compliance Form in the Appendix section of this Alert Service Bulletin.
 - a Record the number of affected A-2044 hex nuts removed from the aircraft in the Replacement Parts section on the form.
 - b Send the completed form to Hartzell Propeller for processing.
- (3) Install the spinner dome in accordance with the applicable Hartzell Propeller owner's manual.
- (4) Make an entry in the propeller logbook indicating the affected A-2044 hex nut(s) were replaced in accordance with this Alert Service Bulletin.

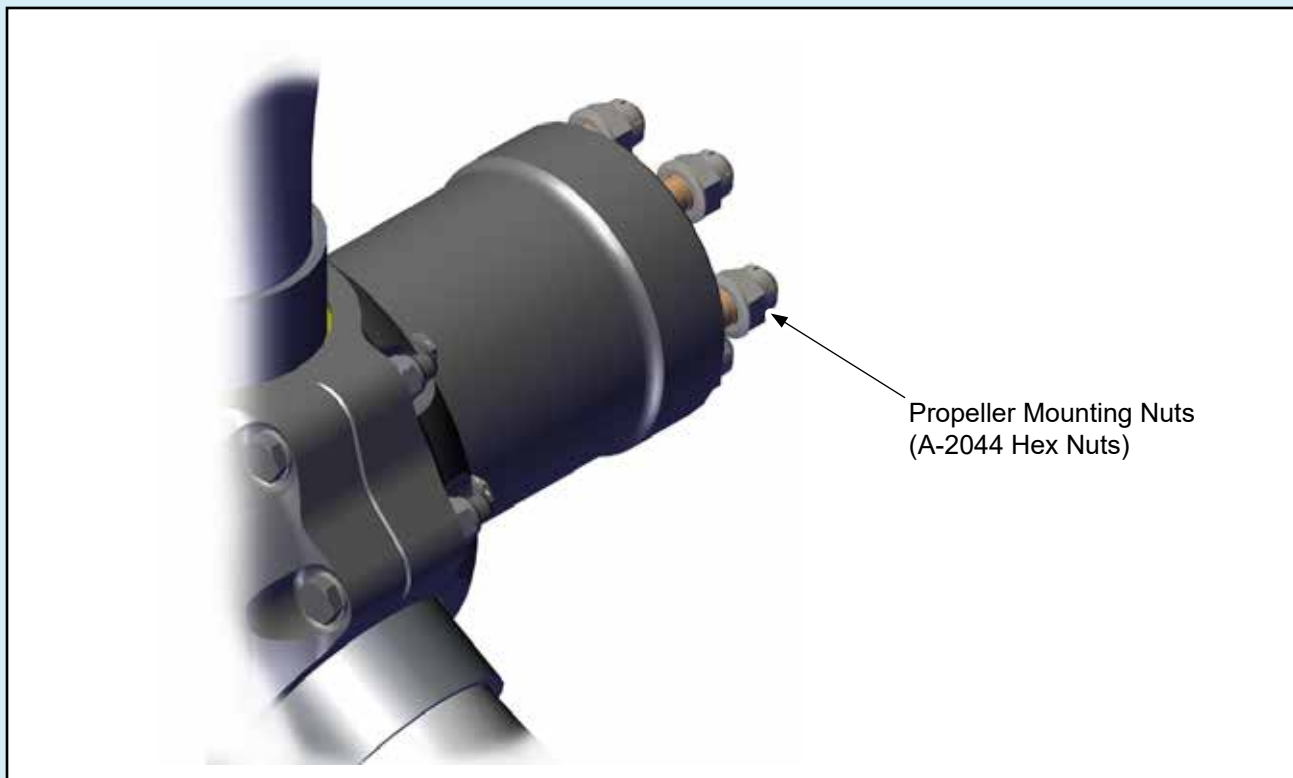
Propeller Mounting Nuts (A-2044 Hex Nuts)
Figure 2

- (1) Remove the spinner dome in accordance with the applicable Hartzell Propeller owner's manual.
- (2) Examine the propeller mounting nuts (Figure 2) to identify the lot number marked on each A-2044 hex nut (Figure 1).
 - (a) A-2044 hex nuts marked with lot numbers other than "S6" are not affected by this Alert Service Bulletin and require no further action.
