# SERVICE BULLETIN

CK-SB012

**SUBJECT:** ROTAX FUSEBOX CONNECTOR SEAL INSPECTION AND REPLACEMENT

**SERIAL NUMBERS AFFECTED:** CCX-1865-1001 thru CCX-1865-1015.  
CCX-1865-2001 thru CCX-1865-2020.

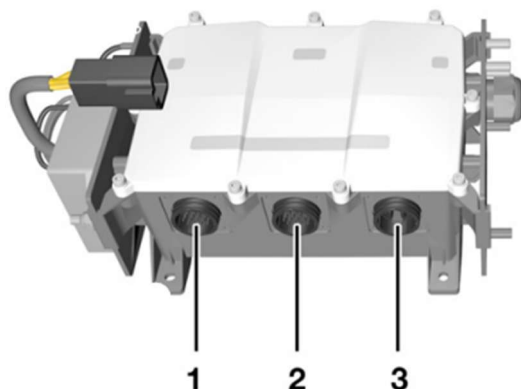
**Figure 1. Fusebox**

- 1. X1 Connector
- 2. X2 Connector
- 3. X3 Connector

1. Read all instructions before beginning any work.
2. Remove the upper cowling per the AMM.
3. On the fusebox, located on the upper firewall, disconnect the X1 connector from its socket as shown in Fig. 1.

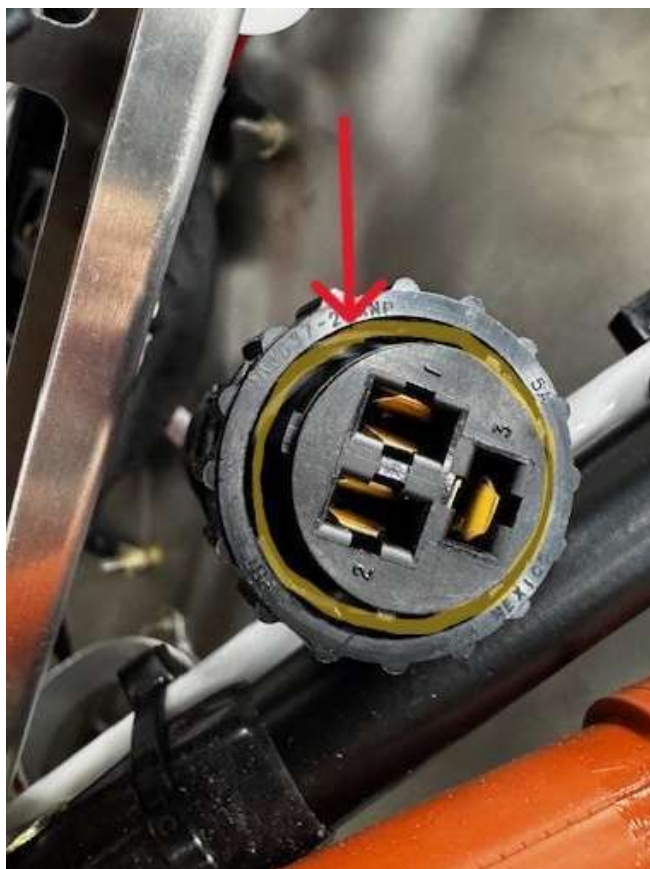
**Figure 2. Male side fusebox connector. (Rubber seal location highlighted in yellow for clarity)**

**PURPOSE:** CubCrafters has found that the rubber seals on the fusebox connectors have potentially been incorrectly installed or missing altogether. The purpose of this Service Bulletin is to ensure that the fusebox seals are inspected and correctly installed to enable a good connection between plug and socket.

- 4. Inspect the male side connector for the misplaced or missing rubber seal. If misplaced, it will be located in the gap in the connector, indicated in Fig. 2.

5. Remove the misplaced rubber seals using a pick or another thin tool.
6. Install SP56102-001 INTO the X1 connector on the fusebox side as shown in Fig. 3. If it is difficult to get the seals in place, it is acceptable to put a small dab of DC4 or equivalent on the seal to help it stay up in the fusebox connector while plugging it into the box.
