**SUBJECT:** ROTAX FUSEBOX CONNECTOR SEAL INSPECTION AND REPLACEMENT

**SERIAL NUMBERS AFFECTED:** CC11-01001 thru CC11-01005.

# SERVICE BULLETIN

SB00041

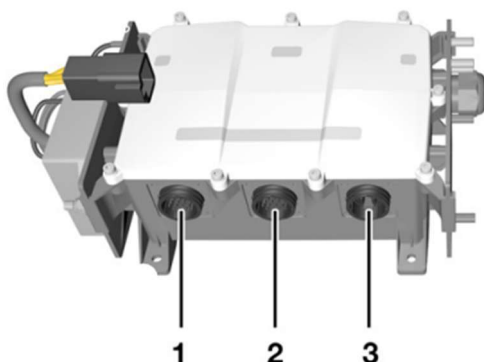
Figure 1. Fusebox

1. Read all instructions before beginning any work.
2. Remove the upper cowling per the AMM.
3. On the fusebox, located on the upper firewall, disconnect the X1 connector from its socket as shown in Fig. 1.

1. X1 Connector
2. X2 Connector
3. X3 Connector

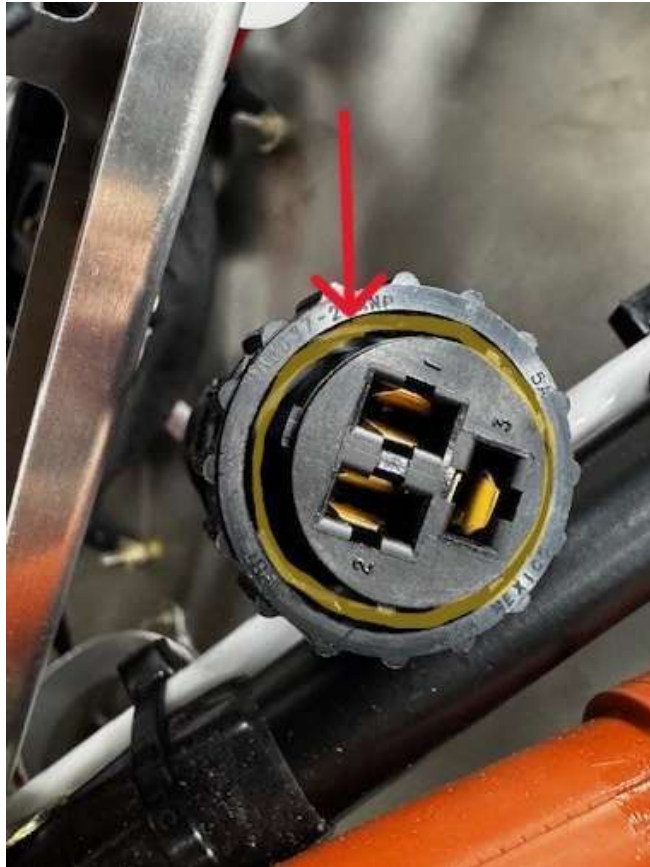
4. Inspect the male side connector for the misplaced or missing rubber seal. If misplaced, it will be located in the gap in the connector, indicated in Fig. 2.

**Figure 2. Male side fusebox connector. (Rubber seal location highlighted in yellow for clarity)**

5. Remove the misplaced rubber seals using a pick or another thin tool.
6. Install SP56102-001 INTO the X1 connector on the fusebox side as shown in Fig. 3. If it is difficult to get the seals in place, it is acceptable to put a small dab of DC4 or equivalent on the seal to help it stay up in the fusebox connector while plugging it into the box.

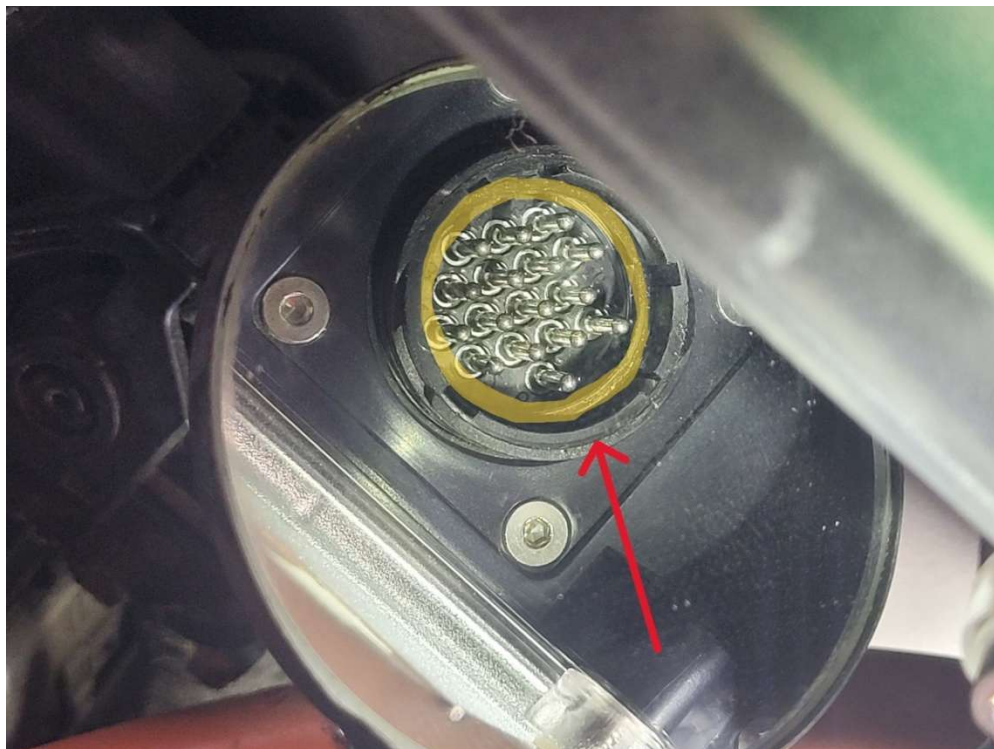
**Figure 3. Fusebox connector with seal. (Rubber seal location highlighted in yellow for clarity)**

- 7.** Connect the X1 cable into the corresponding plug in the box, ensuring that the connector enters the plug straight, as it is possible to install it crooked. Screw the lock ring tight, and repeat several times to ensure the connector is fully secure
- 8.** Repeat steps 3-7 for the X2 and X3 connectors.
- 9.** Re-install the cowling per the AMM.
- 10.** Perform an operational check, including a ground run, to ensure that the work was performed correctly and all electrical components are operational.
- 11.** Make logbook entry stating that SB00041 Rev NC was complied with. There is no change to weight & balance.
