# SAFETY ALERT SA0008

**SUBJECT:** Additional Electrical Protection

**MODELS AFFECTED:** CC11-100 and CC11-160 S/N 0001, 00002 through 00177.

**PURPOSE:** It has been determined that electrical wiring behind the instrument panel may chafe against adjacent equipment. This Safety Alert addresses this by adding protective chafe tape to the affected areas and inserting fusible links in certain electrical circuits.

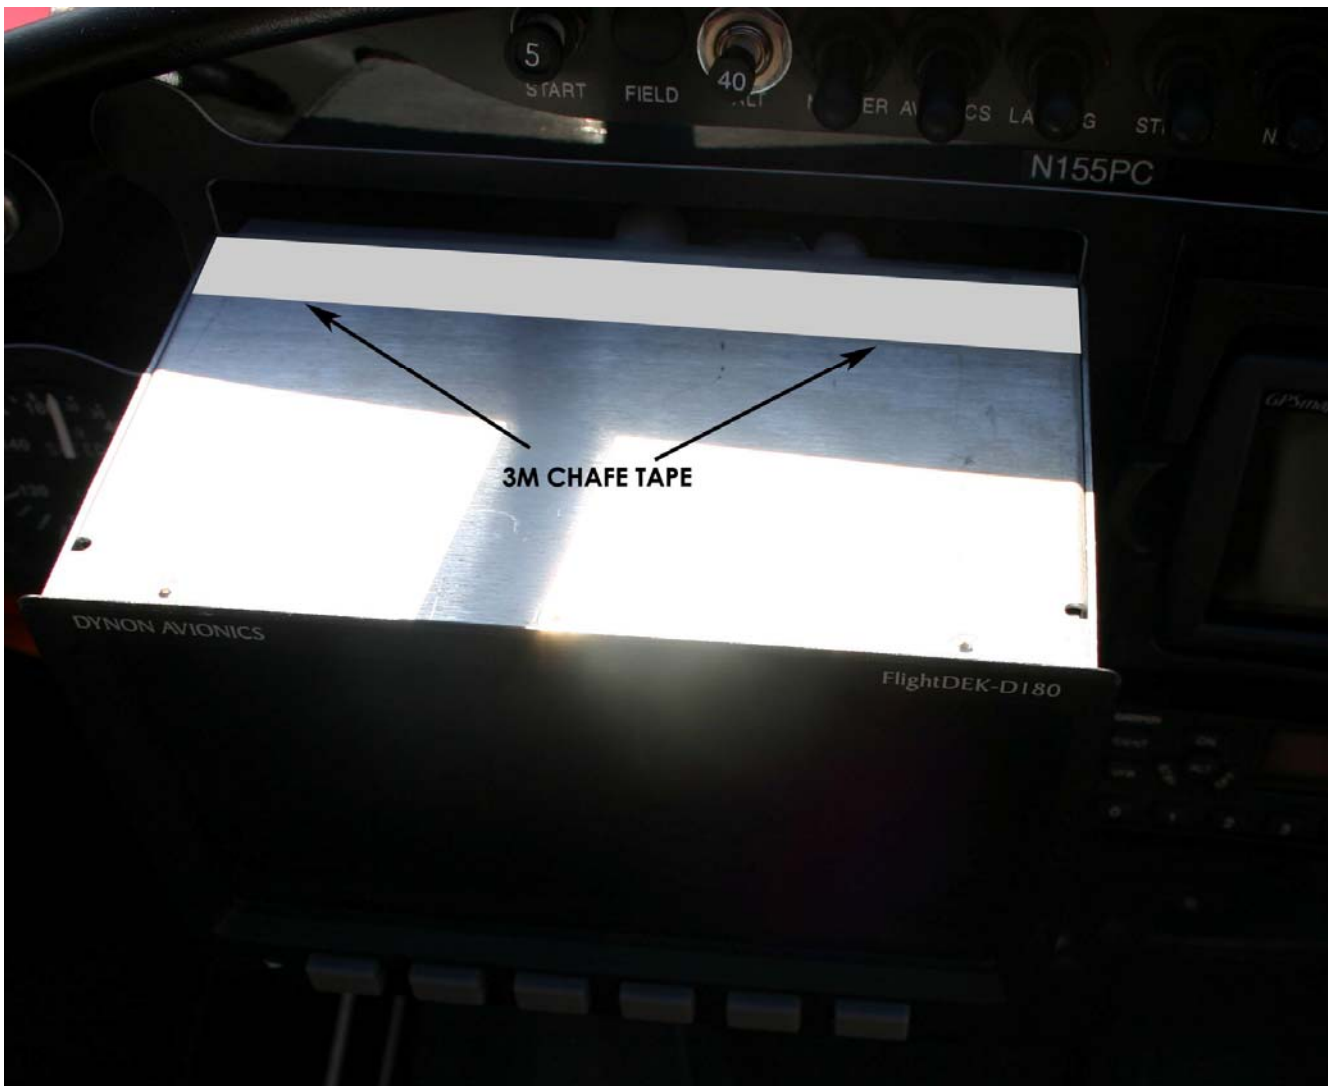
**Figure 3 - Upper part of Dynon with chafe tape installed**

- ii. Apply 3M chafe tape along (aircraft) forward edge where wires might rub. (See Figure 3)

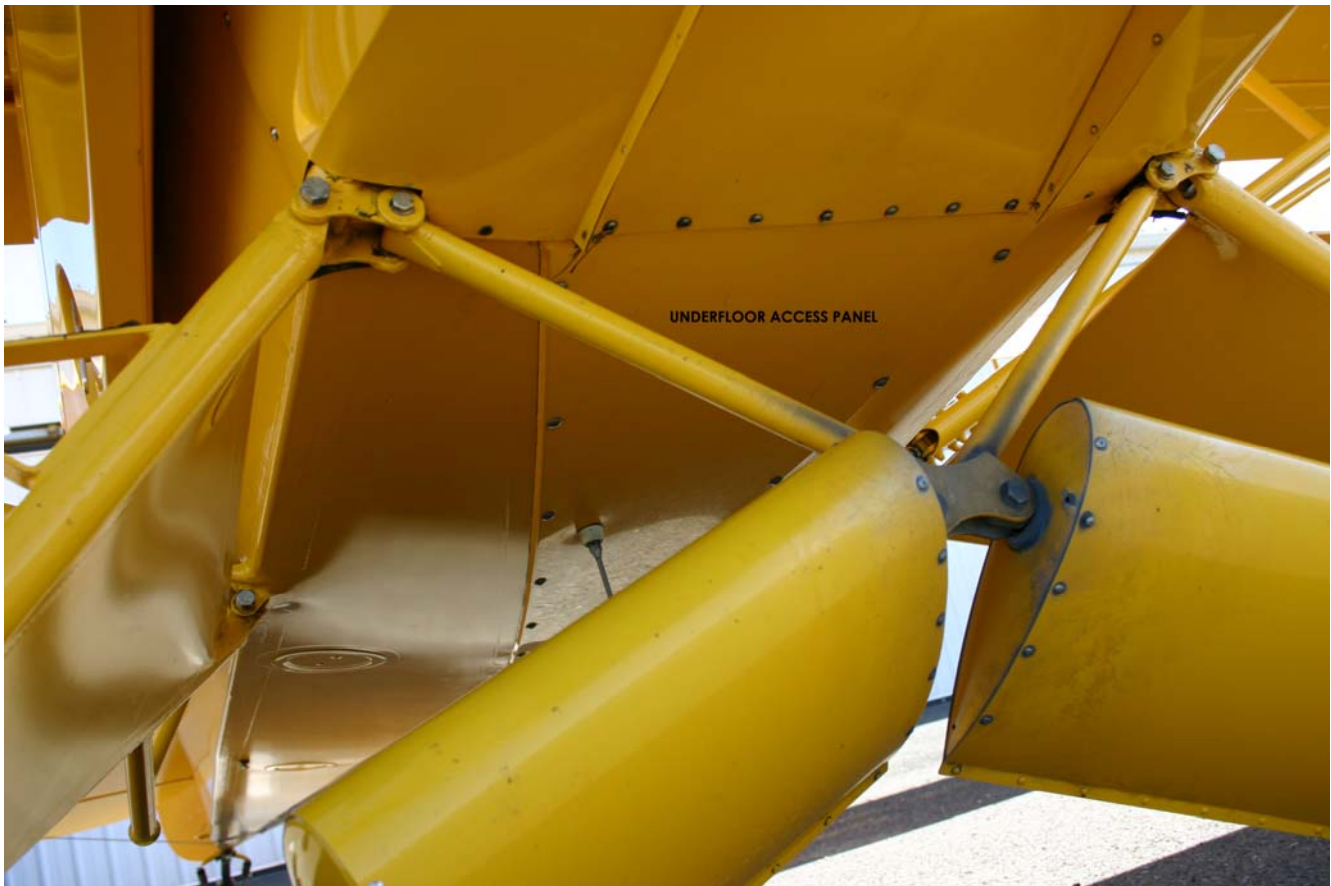
**Figure 4 - Lower access panel**

3. **All aircraft not equipped with Dynon FlightDEK-D180.**
  - a. Inspect wiring behind instrument panel, particularly around avionics baskets. If chafing is found, contact Cub Crafters for repair instructions.
4. **All Aircraft:** Installation of a fusible link under the floor of the aircraft:
  - a. Gain access to the under floor area of the aircraft by removing the triangular access panel on the belly of the aircraft. (See Figure 4)
    - i. Com whip antenna is mounted on this panel
    - ii. Disconnect antenna, lead, and ground wire. Remove panel.

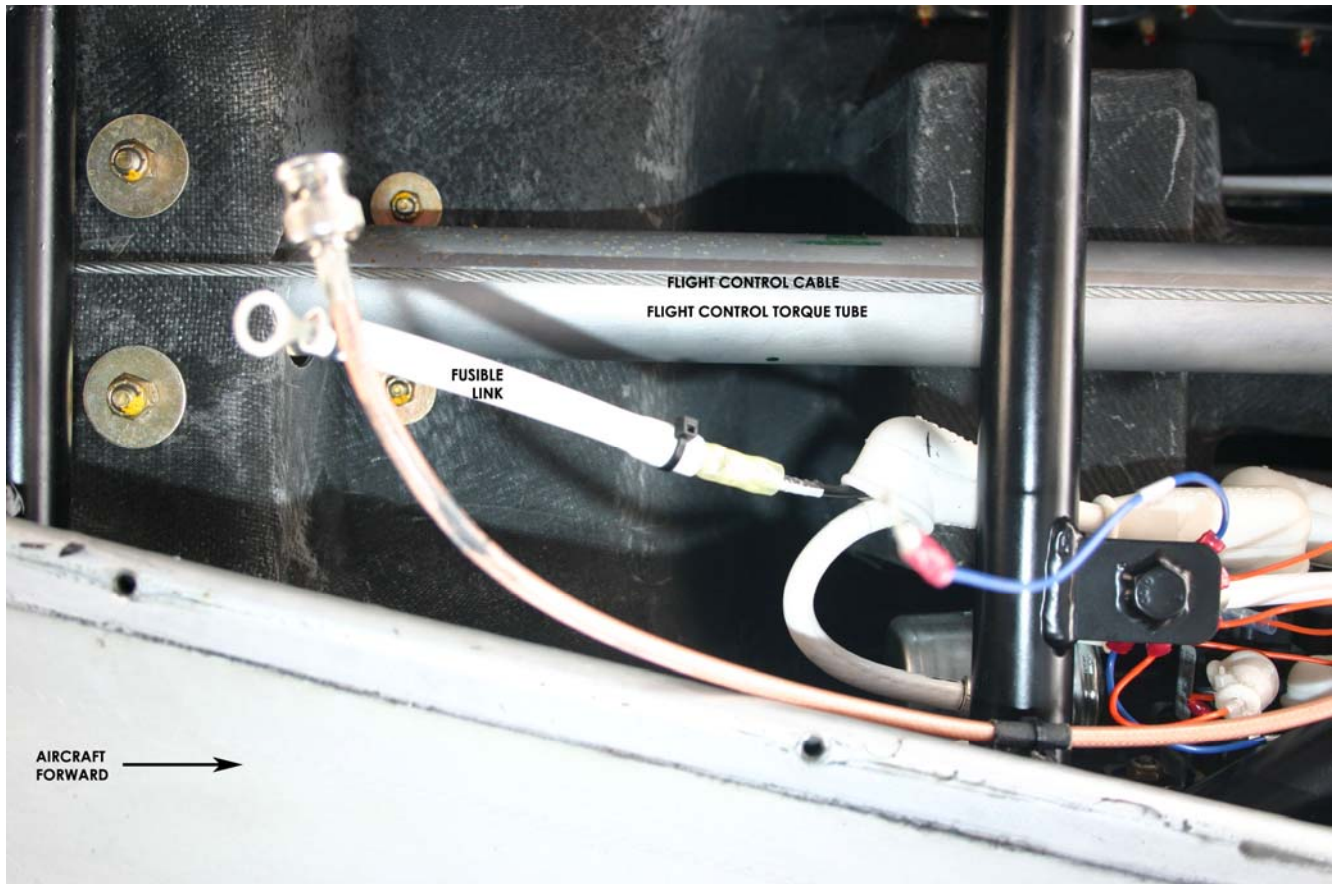
**Figure 6 - Fusible Link Spliced on P03A10BK**

- iii. Crimp on the SC71021-001, Fusible Link, onto the P03A10BK wire per AC43.13 or AC65-15A. (See Figure 6)

- iv. Attach Fusible Link to solenoid where P03A10BK was disconnected.
  - v. Ensure appropriate wire clearances and routing around flight controls in this area. Secure P03A10BK as appropriate.
  - vi. Reattach com antenna, lead and ground. Reinstall belly panel.
- 5. All Aircraft:** Inspection and installation of a fuse holder and fuse in wire going up left, forward window post:
- a. Locate MB04A\_\_\_\_. This is the wire that carries electrical power from the instrument panel up the left window post; it may be one of the following wires:
    - i. MB04A16BN, a brown 16 GA wire (most Sport Cubs).
    - ii. MB04A20O, an orange 20 GA wire (some early Carbon Cubs).

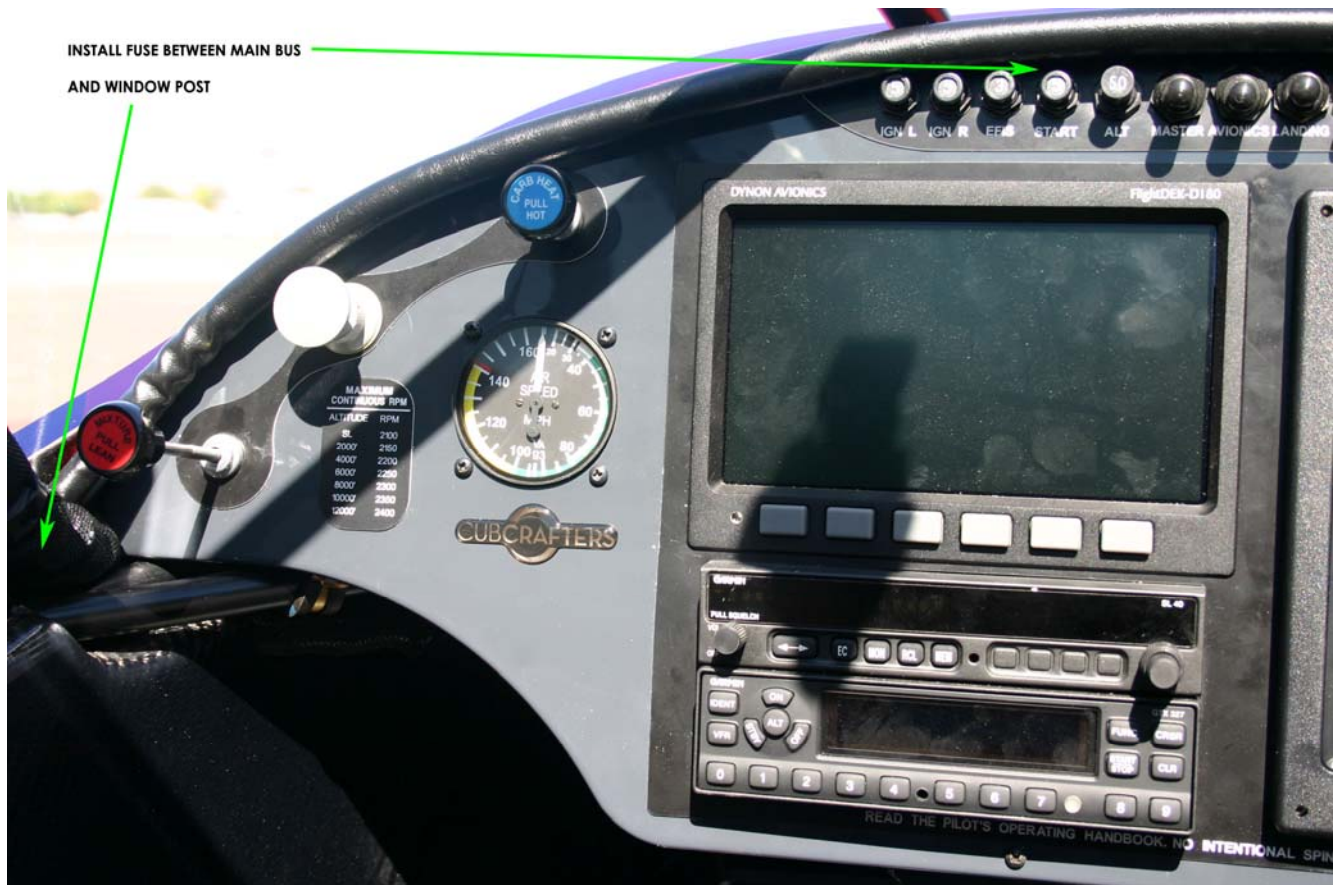
**Figure 7 - Location of fuse holder and fuse**

- iii. MB04A20W-1, a white 20 GA shielded wire (later Carbon Cubs and current production) will have 20S stamped along its length.
- b. Between the main bus and left window post cut this wire.
  - i. As close to bus as accessible.
- c. Install fuse holder, SP55005-001, and 10 amp fuse, SP55011-001.
  - i. If shielded wire, splice fuse holder to center conductor only.
