# SAFETY ALERT SA0009 Rev A

**SUBJECT:** CC11 TAIL WIRE MODIFICATION

**MODELS AFFECTED:** CC11-100 AND CC11-160 S/N 0001 THROUGH 00302. S/N 00095 EXEMPT.

**PURPOSE:** Cub Crafters has learned of cases where tail wires have failed in service. This Safety Alert requires installation of a modification to prevent these failures and REPLACEMENT OF TAIL WIRES.

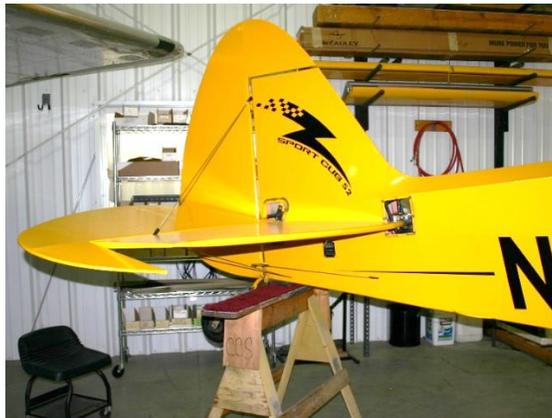
**Figure 1: Tail Support**

1. Read and understand all instructions before attempting any modification to the aircraft.
2. Elevate tail of aircraft and support on the forward tailwheel spring bolt as shown in Figure 1.

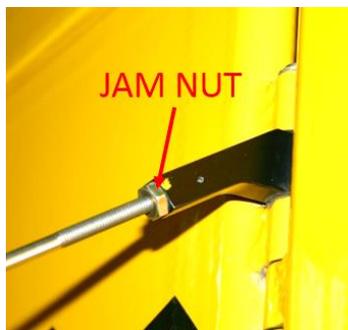
**Figure 2: Jam Nut**

3. Set trim to takeoff position as described in section 4.4.1.1 of the Aircraft Flight Manual (SSC10000AFM)
4. Remove cotter pins and inboard washers from outboard elevator hinge pins.
5. Remove cotter pin and bottom washer from upper rudder hinge pin.
6. Remove round inspection cover on fuselage under the left horizontal tail surface.
7. Loosen jam nuts at the top end of the lower wires and both ends of upper wires on both sides. The jam nuts at the top end of the upper wire have left hand threads.

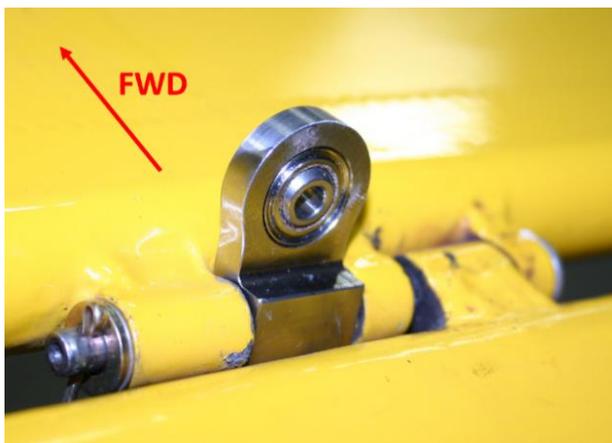
**Figure 3: Horizontal Tail Bracket**

13. Install new horizontal tail brackets (SC81015-001) from the SA00009 kit onto the hinge pin as shown in Figure 3 and reinstall the hinge pin and spacer washers. Install new cotter pins on the elevator hinge pins.

The flat side of the horizontal tail bracket should face the front of the aircraft

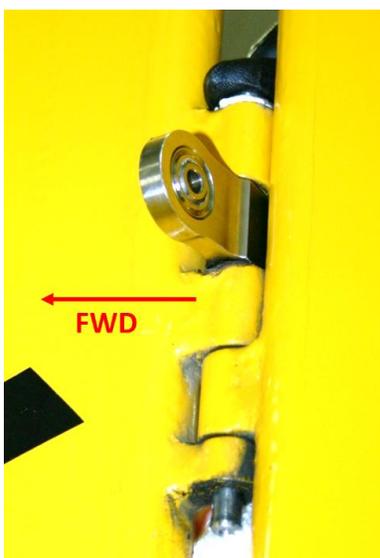
**Figure 4: Vertical Tail Bracket**

14. Install the new vertical tail bracket (SC81015-003) from the SA0009 kit onto the hinge pin as shown in Figure 4 with the lugs angled toward the front of the aircraft. Again, take note of the spacer washer positions before removing the hinge pin and re-install them after installing the bracket. Install a new cotter pin on the rudder hinge pin after the washers and bracket have been installed.

The vertical tail bracket's lugs should be angled toward the front of the aircraft.

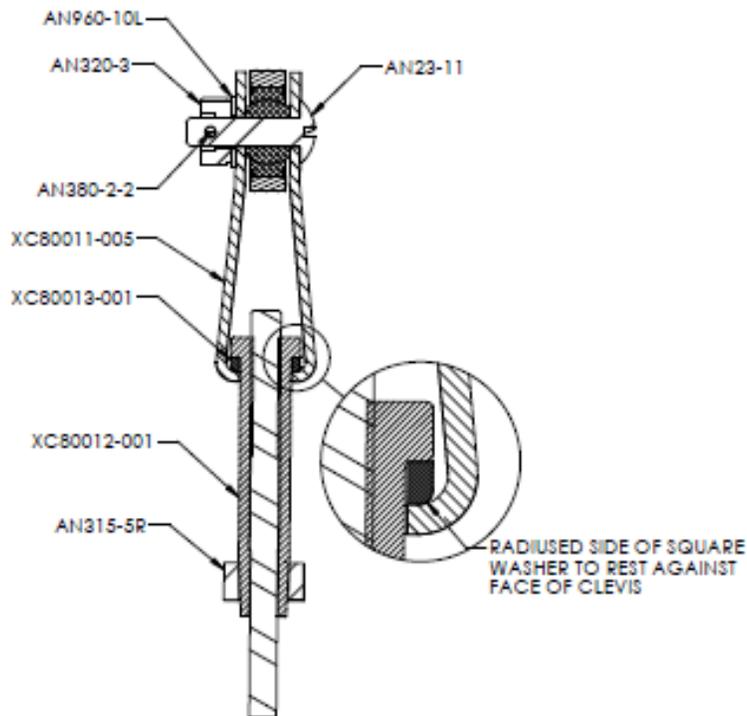
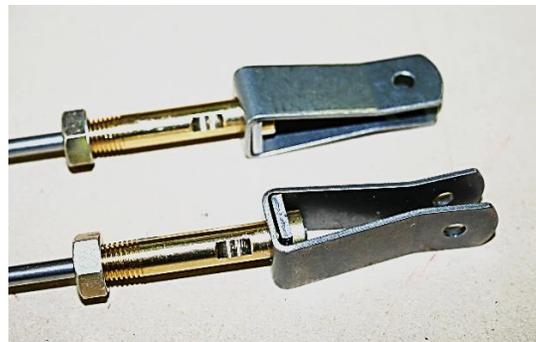
**Figure 5: Clevis Assembly**

15. Assemble the clevis assembly onto new wires as shown in Figure 5. The longer wires are the upper wires and require a clevis assembly on each end. **Take note of the orientation of the square washer. It is very important that the rounded edge of the washer be seated inside the bends of the clevis.** The shorter wires are the lower wires and require only one clevis assembly. The clevis assembly attaches to the end of the lower wire with a full 1-1/2 inch of threads. The end with the shorter threads will be inserted into the fuselage. Thread the wire into the brass nipple until the end of the wire is flush with the end of the brass nipple inside the clevis. This is the longest the wire assembly can be and still provide sufficient thread engagement. **Do not tighten the nuts on the brass nipples at this time.**

The clevis assemblies are identical and interchangeable between wires.

The rounded edge of the square washer must be seated inside the bends of the clevis.

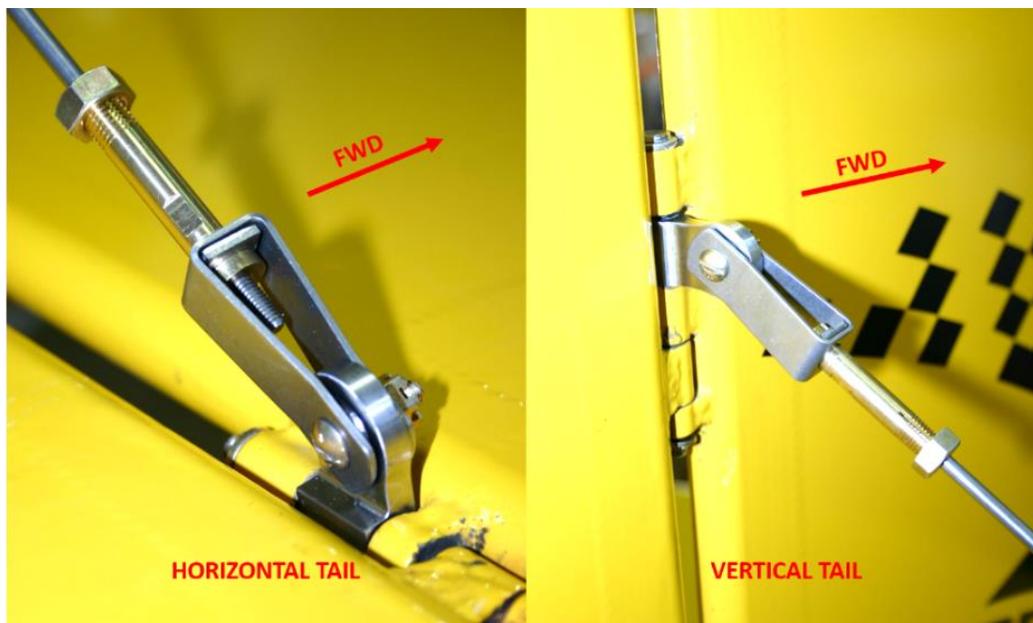
**Figure 6: Upper Wire Installation**

16. Install the upper wires to the new brackets adjusting wire length as necessary. Align the clevis holes with the holes in the bracket's spherical bearings and insert an AN23-11 clevis bolt. The head of the clevis bolt should be on the AFT side of the bracket. Install an AN960-10L thin washer and AN320-3 castellated shear nut on the FORWARD side of the bracket. Tighten the nut 12 in-lbs then beyond 12 in-lbs up to one nut flat until a cotter pin can be inserted. The clevis should pivot freely on the bracket. Install cotter pin to lock castle nut in place. Repeat for the other side.

Ensure an equal amount of threaded wire is extending beyond the brass nipple into the clevis on each end of the wire. The wire must extend through the brass nipple and be visible from the clevis side in order to keep the brass nipple from clamping on the wire's threads when the lock nut is tightened. Threads should not show on the wire by the jam nut

The AN23-11 bolt heads attaching the upper wire to the brackets must be on the aft side of the bracket with the nut on the forward side. This is opposite standard convention.

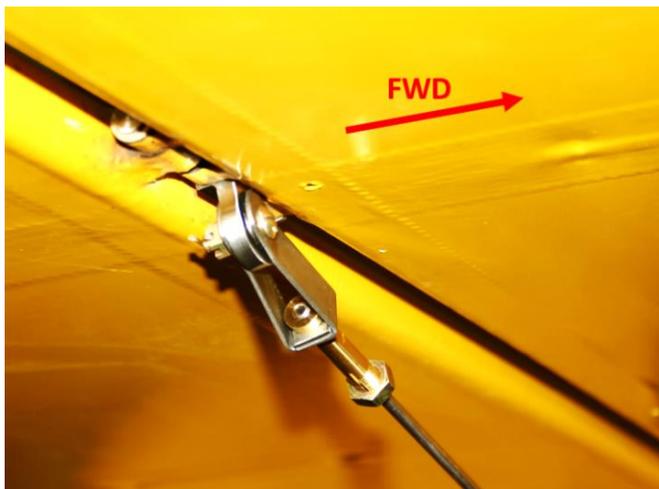
**Figure 7: Lower Wire Installation**

17. Slip the bottom end of the lower wires (the end without the clevis) into the bushings in the fuselage where the previous wires were attached. Attach the upper end (with the clevis assembly) to the bottom of the bracket on the elevator hinge pin. Align the clevis holes with the holes in the bracket's spherical bearing and insert an AN23-11 clevis bolt. The head of the clevis bolt should be on the FORWARD side of the bracket. Install an AN960-10L thin washer and AN320-3 castellated shear nut on the AFT side of the bracket. Tighten the nut to 12 in-lbs then beyond 12 in-lbs up to one nut flat until a cotter pin can be inserted. The clevis should pivot freely on the bracket. Install a cotter pin to lock castle nut in place. Repeat for the other side.

The AN23-11 clevis bolts on the lower wires should be facing opposite the bolts installed on the upper wires. The bolt heads should be on the forward side of the bracket with the nut on the aft side of the bracket. This follows standard convention.

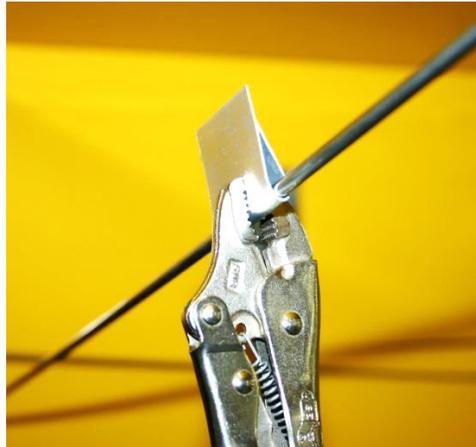
**Figure 8: Protected Wire**

18. Install an AN960-10 thick washer and AN365-1032A nylon lock nut onto the bottom ends of the lower wires inside the fuselage. There should be 1-1/2 to 3 threads protruding through the nut. Hold the wire with vice grips, protecting the wire with the included piece of aluminum as shown in Figure 8.

**Do not mark the wire with vice grips. Be sure to protect the wire from any tools with the included protective aluminum. Any tool marks on the wire greatly reduce their ability to handle high loads and make the aircraft un-airworthy. Use just enough clamping force to sufficiently grip the wires without slipping. Too much force could also damage the wires.**

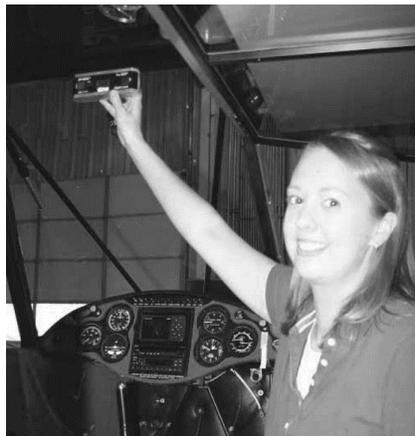
**Figure 9: Leveling the Aircraft**

19. Verify elevator trim is in the center of the takeoff position.
20. Level the aircraft laterally by placing a level on the upper forward cross tube located in the cabin just behind the windshield, as shown in Figure 9. Center the bubble to level the wings. It is not necessary to level the aircraft longitudinally. Reference section 6.3.2 of the Aircraft Flight Manual (SSC10000AFM) for detailed leveling instructions.

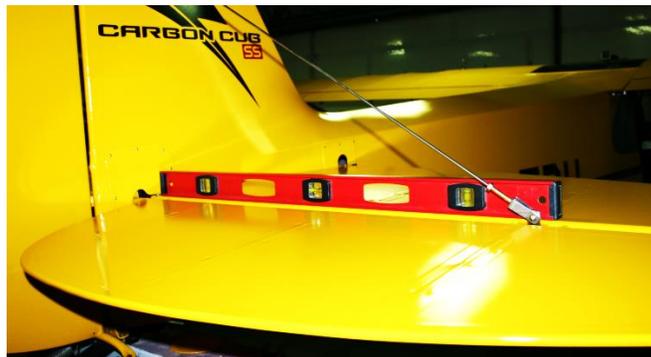
**Figure 10: Leveling Horizontal Tail**

21. Place a level on the rear spar of each horizontal tail. Adjust the wire lengths by turning the brass nipples at either end of the top wires and upper ends of lower wires until both horizontal tail surfaces are level laterally and the vertical fin is vertical. It will be necessary to turn the brass nipples with a  $\frac{9}{32}$ " wrench on the wrench flats. Check that the vertical fin is perpendicular to the horizontal tail using a level.

No threads should show on the wire by the jam nut. Make sure the same amount of threads extend into the clevis on opposite ends of the same wire. Also, be sure the clevises are positioned so that there is an equal gap between either side of the bracket and the clevis and ensure the spherical bearing can pivot freely.

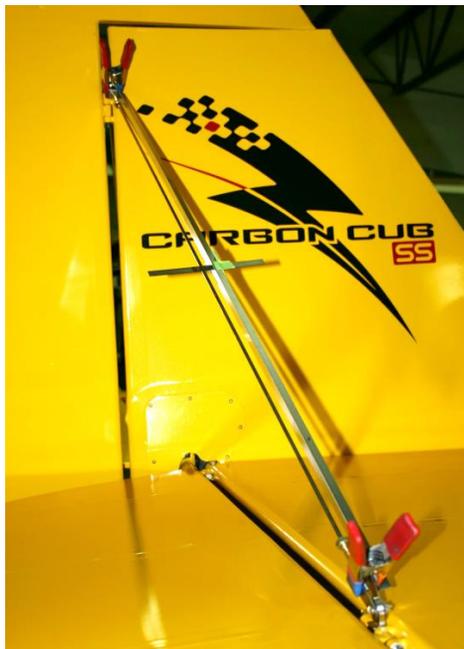
**Figure 11: Straight Edge Attachment**

- 22. Check that wire tensions are within specifications. Start by attaching a 6" ruler to the center of the included straight edge. Clamp the straight edge to the wire clevises on one of the top wires as shown in Figure 11.

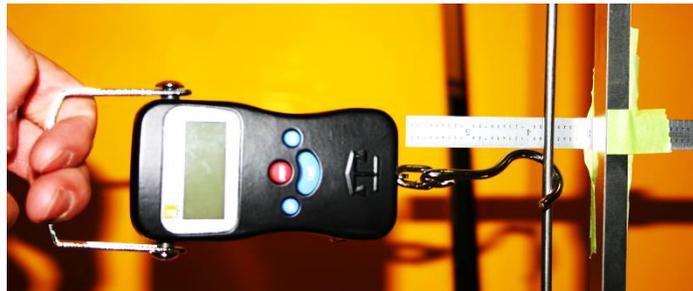
**Figure 12: Wire Tension Measurement**

23. Measure the wire tension by pulling in the center of the wire with a calibrated fish scale. The deflection of the wire should be between  $\frac{7}{16}$  inch and  $\frac{9}{16}$  inch when the scale reads 10 lbs ( $\pm 0.5$  lbs) as shown in Figure 12. Adjust the wire tension by grasping the wire with vice grips and rotating the brass nipples on the wire. Be sure to protect the wire from the vice grips with the included protective aluminum.

24. Once wire tension is set re-check that the tail is still level and true. If the tail is no longer level and true, re-adjust the wires and re-tension. Tighten the jam nuts on the brass nipples. Carefully hold the nipple with a  $\frac{9}{32}$  inch wrench while tightening the jam nut to 70-80 inch-lbs with a  $\frac{1}{2}$  inch wrench.

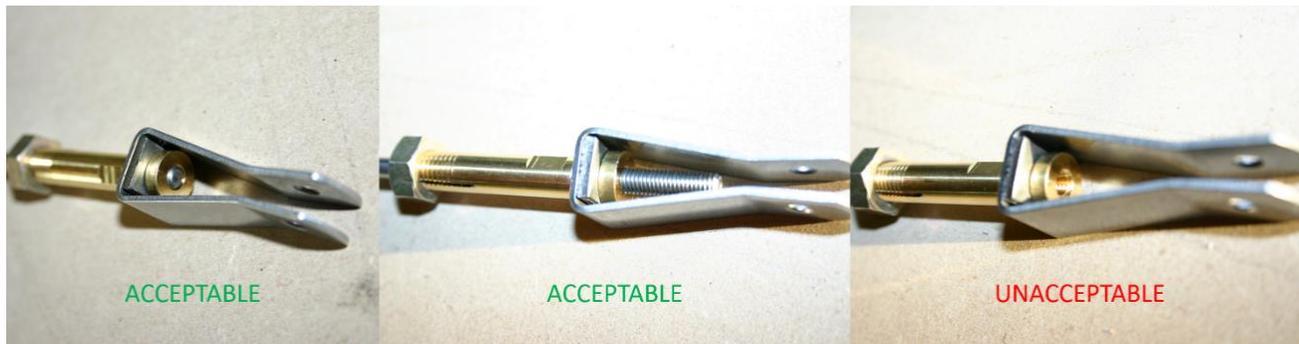
**Figure 13: Acceptable Threading**

28. Verify that all 6 brass nipples have jam nuts that have been tightened to the proper specifications and that no wire threads are exposed along the wire past the jam nut on the brass nipple. It is acceptable for some threads to extend through the brass nipple into the clevis. The threads that do extend through the nipple into the clevis should extend approximately the same amount on opposite ends of the same wire. The wire must extend through the brass nipple and be visible from the clevis side in order to keep the brass nipple from clamping on the wire's threads when the lock nut is tightened.
