SUBJECT: Oil Line Additional Support

MODELS AFFECTED: CC11-100 S/N CC11-00001 THRU CC11-00076.

SERVICE BULLETIN

SB00009

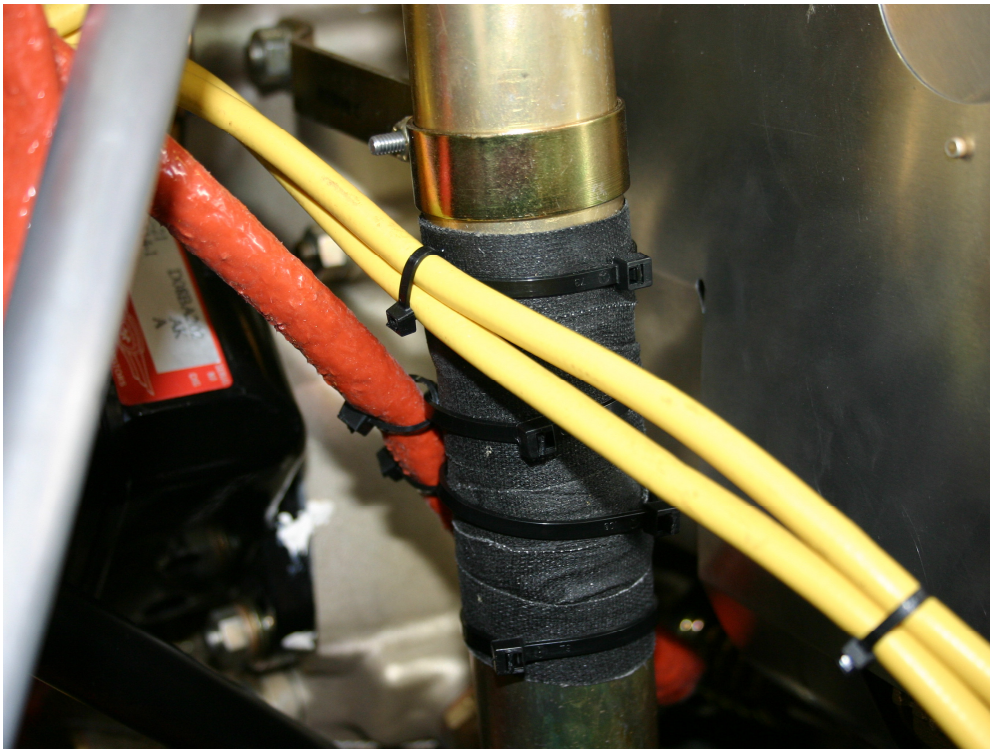
Figure 1 - Securing of the Oil Line to the Oil Filler Neck

1. Remove cowling.
2. Using anti-chafe wrap and cable ties, secure the fire sleeved oil line to the oil filler neck (use the nearby attachment of the spark plug wires as a guide). Ensure the line is in a relaxed and unstressed condition on either side of the attachment to the oil filler neck. Refer to Figure 1.
3. Make a note in the aircraft logbook that Service Bulletin SB0011 has been complied with.
