SERVICE BULLETIN

SB00032

- EFFECTIVE DATE:** This Service Bulletin is effective **October 16, 2015.**
- SUBJECT:** *ENGINE INDUCTION HOSE REPLACEMENT*
- MODELS AFFECTED:** *ALL CC11-160 THROUGH S/N 00384*
- COMPLIANCE TIME:** *INSPECTION REQUIRED BEFORE NEXT FLIGHT
INSTALLATION DUE AT NEXT MAINTENANCE ACTION*
- PURPOSE:** *Induction leaks have been reported as a result of induction hose disbonding. New induction tube couplers provide better overall functionality.*
- WARRANTY:** Aircraft under warranty will be provided parts at no cost and receive up to 3 hours of labor, if work is performed at a Cub Crafters Authorized Service Center. Please contact Cub Crafters Customer Support for assistance.

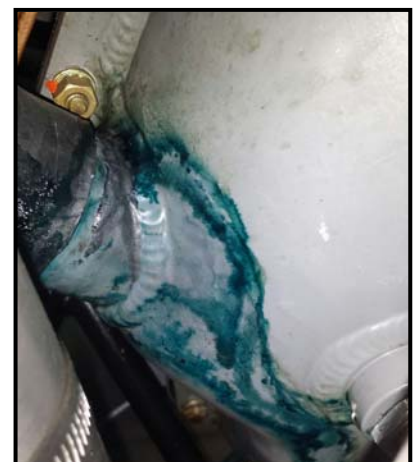
2. Remove cowl, retaining all fasteners. (Ref. AMM 6.3.14).
3. Inspect for any wear, corrosion, or damage that would cause an unsafe condition for operation.
4. Check for evidence of any fuel leaks around the induction hoses (see Figure 1). If no leaks are obvious, replacement may be completed at the next maintenance action. Proceed to replacement steps if leaks are apparent.

FIGURE 1 – Leaking Hose

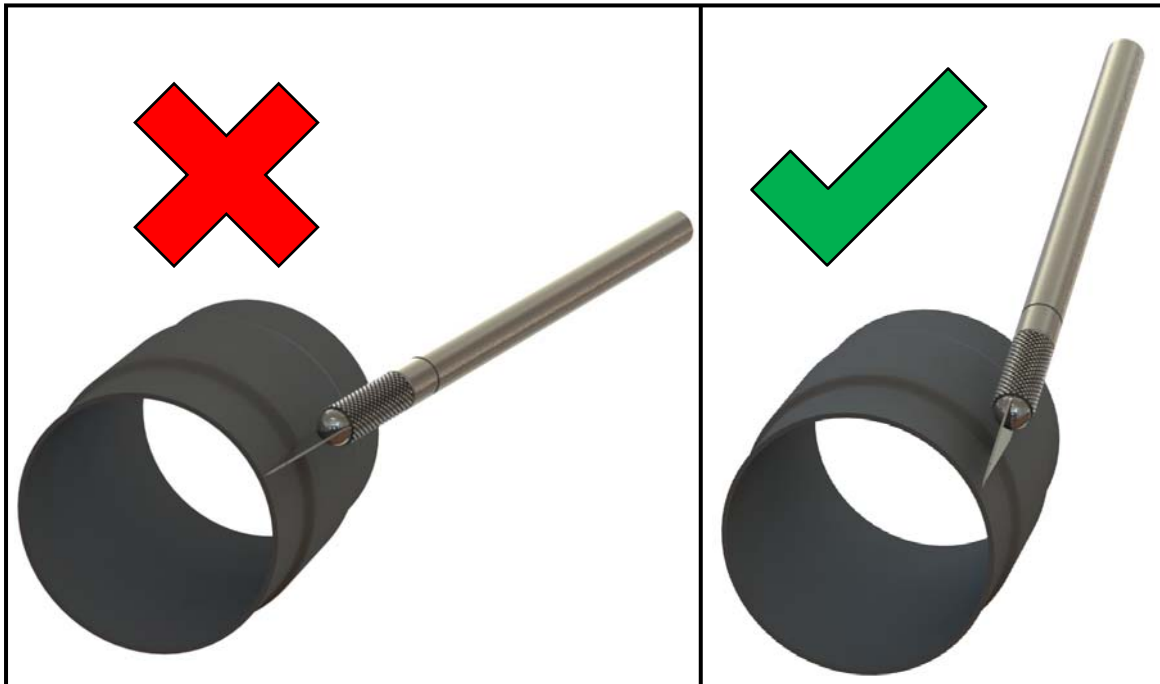
FIGURE 2 – Cutting Induction Hose

5. Cut off existing induction hoses and cable ties from induction tubes. Ensure the blade is parallel to the tube so as not to gouge the tube (see Figure 2).

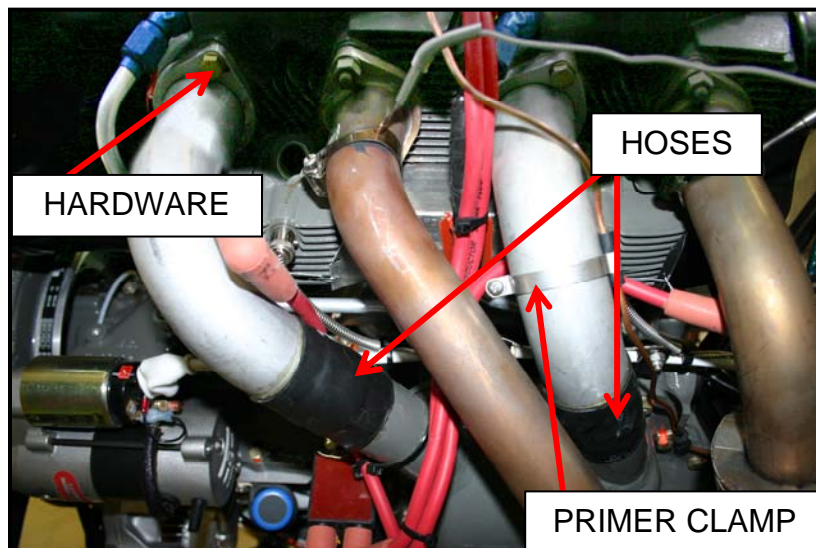
FIGURE 3 – Induction Tube Assembly

6. Remove and retain hardware from the flange of each induction tube. Loosen and remove primer line clamp from the left aft induction tube. Discard old lock washers and replace with new parts.

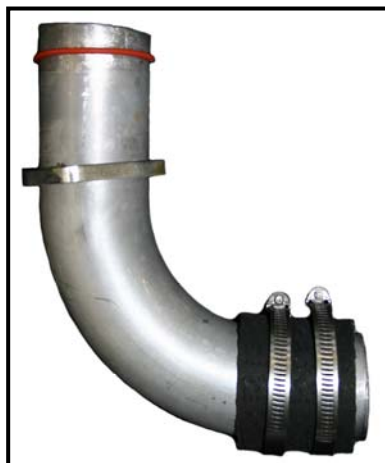
FIGURE 4 – Tube Assembly

10. Apply lubricant (DC4) onto the O-ring and slide onto top of the tube. Measure 1" from the bottom edge of the tube and mark line. Install induction tube coupler onto induction tube, using alcohol if required. Slide two HDW-100-213 clamps onto the coupler (see Figure 4).

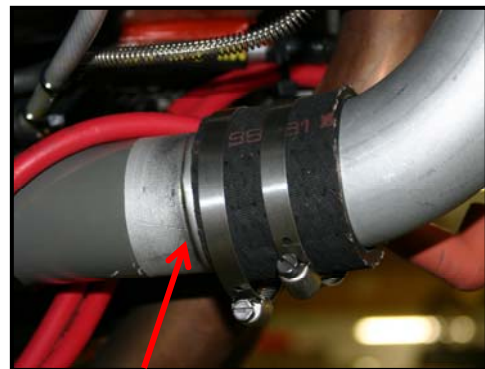
FIGURE 5 – Gap Width Example

11. Position the top of the induction tube into the cylinder and reinstall hardware finger tight. Ensure there a minimum 1/16" (maximum 1/4") gap between induction tube and sump induction tube (see Figure 5).

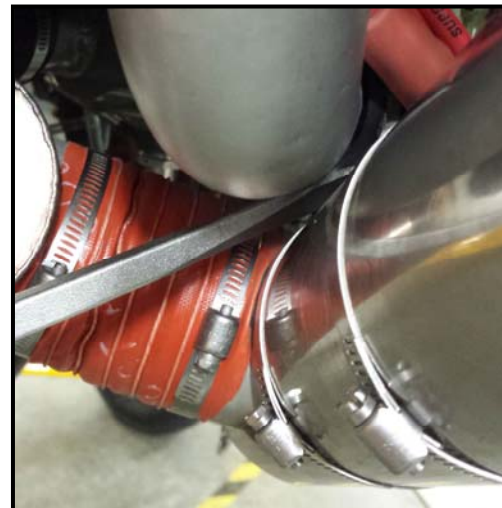
FIGURE 6 – Shroud Relief

15. Reinstall primer line clamp, heat muffs, clamps, and connecting ducting (if removed in step 8). Ensure there is adequate clearance between the coupler and heat muff. If required, use a flat screwdriver to gently bend the shroud out of the way to prevent chafing (see Figure 6).
16. Perform a run up (per AFM 4.4.3.1) and check proper engine function. Check for leaks post-run up.
17. Reinstall cowl per AMM 6.3.14 after verifying there are no leaks.
18. Make logbook entry stating that the induction hoses were replaced with P/N SC56053-001, O-rings and lock washers were changed, and SB00032 Rev A was complied with. The changes to weight and balance are considered negligible.
