# **SERVICE BULLETIN**

**SB00033**

**SUBJECT**: AFT SEAT INSPECTION

MODELS AFFECTED: CC11-0001 THROUGH CC11-0430 EQUIPPED WITH AN AFT SLING SEAT.

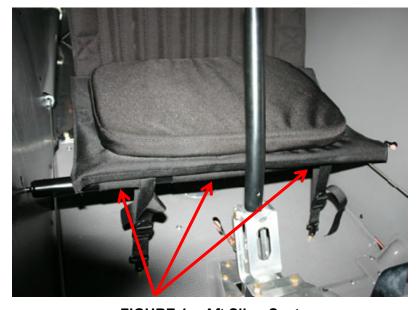
FIGURE 1 – Aft Sling Seat

- 2. Remove the bottom portion of the aft sling seat by disconnecting the two cinched nylon straps from the floorboard, removing the cross bar from the fuselage slots, and sliding the sling seat off of the cross bar (reference the applicable AMM).
- 3. Inspect the stitching on the underside of the cross bar straps (Figures 1 and 2). Inspect for any loose or missing stitches. There should be a minimum of 6 stitches per inch (Figure 3) across the length of the sling seat.

- **4.** If no loose or missing stitches are found, reinstall the aft sling seat (reference the applicable AMM), and skip to step 7.
- **5.** If any loose or missing stitches are found, remove the sling seat from the aircraft by loosening the top straps from the slide connectors. Contact Cub Crafters customer service department for an RMA number at:

- **6.** The seat will be repaired at Cub Crafters, and returned once repaired. Upon receipt of the repaired sling seat, install in the aircraft (reference the applicable AMM).
- **7.** Make logbook entry stating that SB00033 Rev A was complied with. There is no change to weight & balance.
