SERVICE BULLETIN

SK-SB005

SUBJECT: FUEL FITTING INSPECTION

MODELS AFFECTED: All CCK-1865, CCX-1865, CCK-2000, CCX-2000

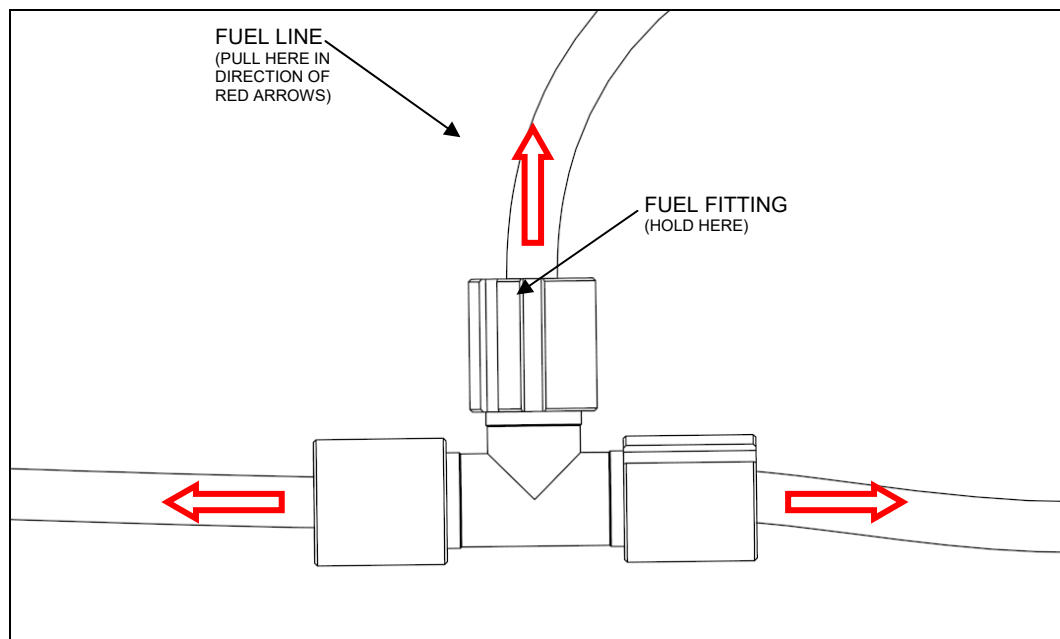
Figure 2 - Tensile Force Application

3. Drain fuel from the aircraft.
4. Apply approximately 7-11 pounds of tensile force on all Nylon fuel lines going through these fittings, by holding the fitting, and pulling on each fuel line. See Figure 2.

It is recommended to pull 7-11 pounds on a fish scale prior to applying the force to the fuel lines as a method to calibrate the pull.

Excessive force on the fuel lines could cause damage to the fuel fittings.

- Cut the zip tie shown in Figure 4.
- Apply approximately 7-11 pounds of tensile force on all aft Nylon fuel lines going through these two fittings (one elbow and one tee). See Figure 2.

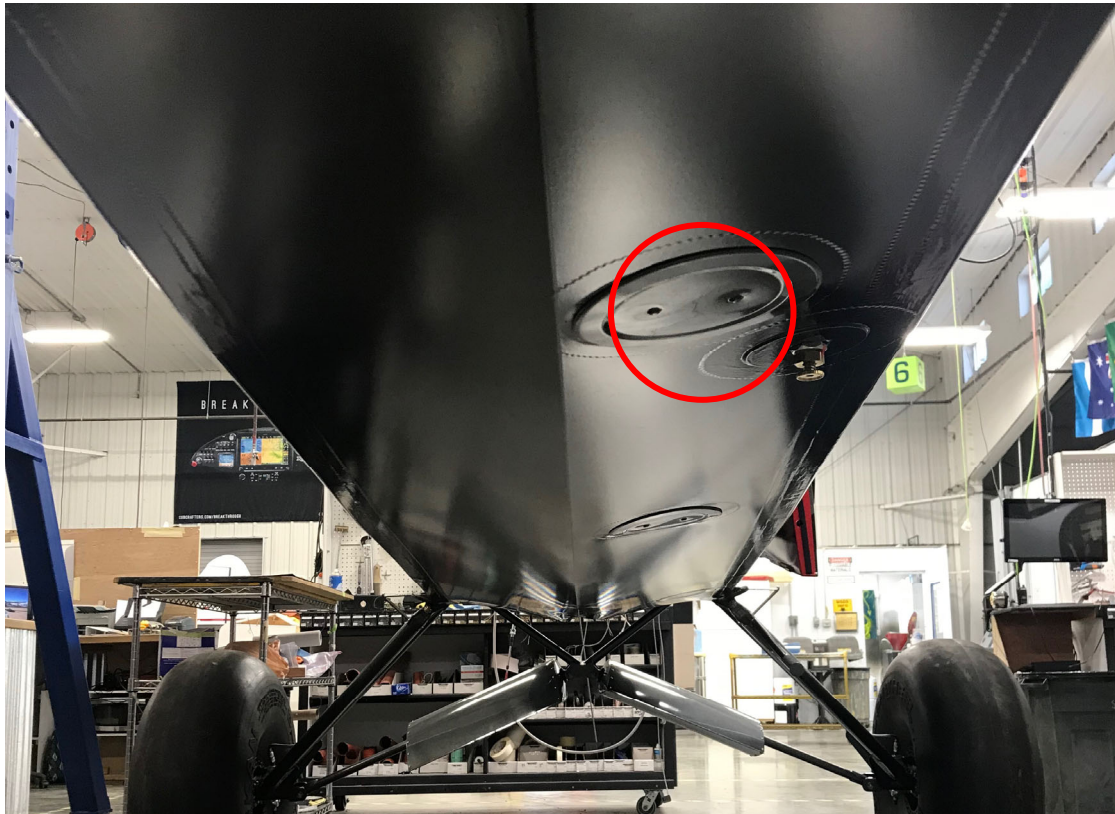
Figure 3 - Inspection Panel Location, Extended Baggage

5. If any fuel lines are loose in the fitting, or if any leaks are found, proceed to the “Fuel Fitting Repair” section of this Service Bulletin. Then continue with step 6.
6. Remove the inspection panel that is located on the belly, behind the aft fuel drain on the right side of the aircraft. See Figure 3. Note that for standard baggage the fuel drain and inspection panel are located one bay forward.

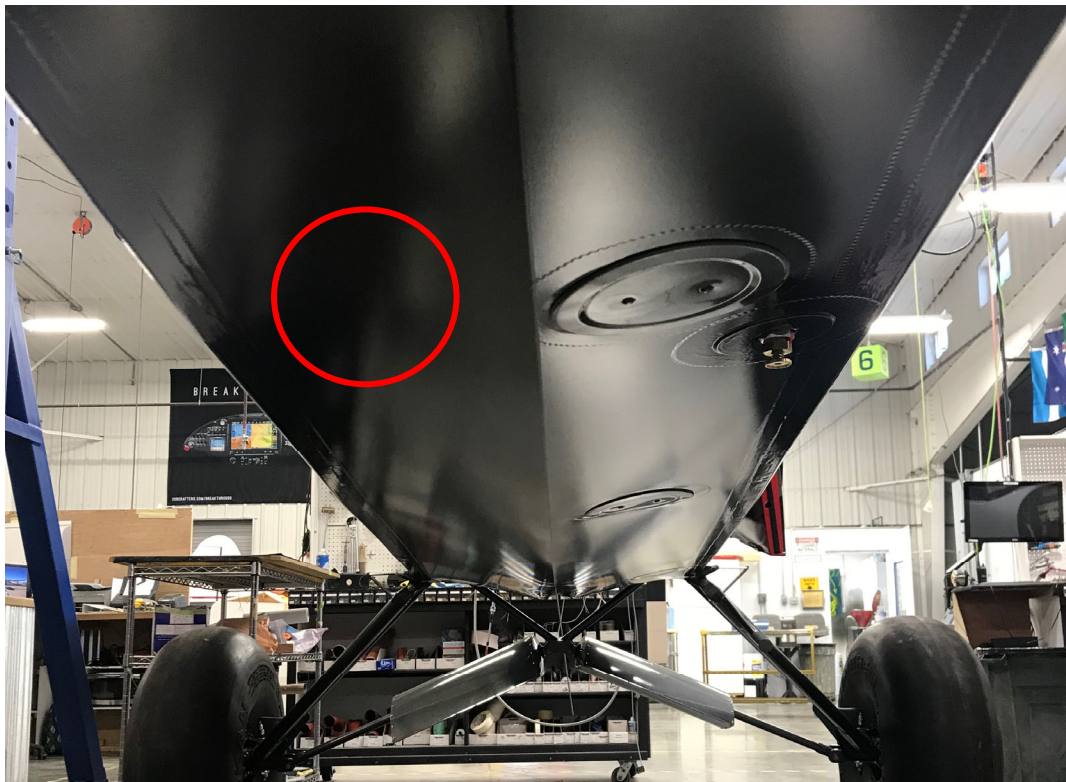
Figure 6 - New Inspection Panel Location

14. The following only applies if a loose fuel line and/or a leak was found during the inspection. If a repair is necessary, contact CubCrafters for parts.
15. If the leaking fuel line fitting is aft of the cargo bay, as seen in Figures 4 and 5, it may be necessary to cut another inspection panel to access the fitting for repair. In this case:
 - a. Position the new inspection cover reinforcement ring - CubCrafters Part Number TC3017-001 - immediately opposite of the panel location shown in Figure 3. It should be located on the opposite side of the fuselage center belly stringer, as shown below in Figure 6.

- b. Adhere the new inspection cover reinforcement ring using Loctite 330. Remove any excess adhesive to prevent paint damage. Wait 6 hours to allow Loctite to cure.

- c. Cut out the fabric inside of the inspection cover reinforcement ring.
16. Remove the leaking fuel fitting(s) by unscrewing the ferrule nuts. Note the nut has been bonded to the compression fitting body; unscrewing the nut may cause it to crack.
