Cub Crafters, Inc. Considers Compliance Mandatory

- EFFECTIVE DATE:** This Service Bulletin is effective **October 16, 2015.**
- SUBJECT:** *ENGINE INDUCTION HOSE REPLACEMENT*
- MODELS AFFECTED:** *ALL CCK AIRCRAFT EQUIPPED WITH CC340 ENGINES*
- COMPLIANCE TIME:** *INSPECTION REQUIRED BEFORE NEXT FLIGHT
INSTALLATION DUE AT NEXT MAINTENANCE ACTION*
- PURPOSE:** *Induction leaks have been reported as a result of induction hose disbonding. New induction tube couplers provide better overall functionality.*

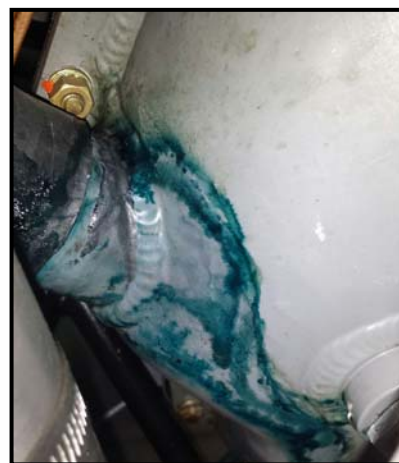
FIGURE 1 – Leaking Hose

2. Remove cowl, retaining all fasteners.
3. Inspect for any wear, corrosion, or damage that would cause an unsafe condition for operation.
4. Check for evidence of any fuel leaks around the induction hoses (see Figure 1). If no leaks are obvious, replacement may be completed at the next maintenance action. Proceed to replacement steps if leaks are apparent.

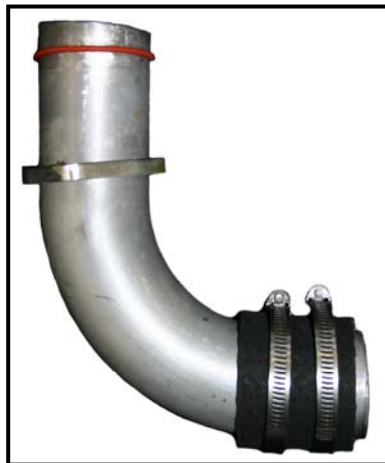
FIGURE 4 – Tube Assembly

10. Apply lubricant (DC4) onto the O-ring and slide onto top of the tube. Measure 1" from the bottom edge of the tube and mark line. Install induction tube coupler onto induction tube, using alcohol if required. Slide two HDW-100-213 clamps onto the coupler (see Figure 4).

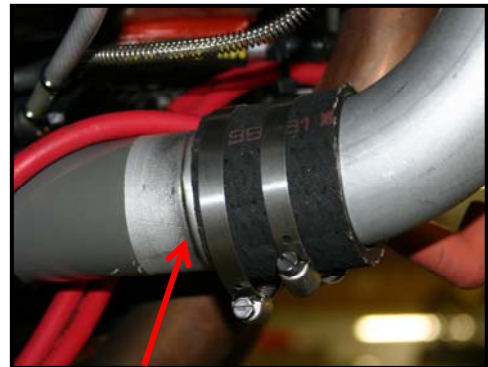
FIGURE 5 – Gap Width Example

11. Position the top of the induction tube into the cylinder and reinstall hardware finger tight. Ensure there a minimum 1/16" (maximum 1/4") gap between induction tube and sump induction tube (see Figure 5).

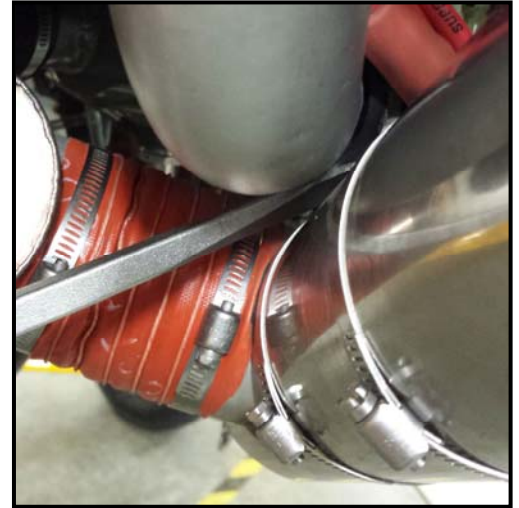
FIGURE 6 – Shroud Relief

15. Reinstall primer line clamp, heat muffs, clamps, and connecting ducting (if removed in step 8). Ensure there is adequate clearance between the coupler and heat muff. If required, use a flat screwdriver to gently bend the shroud out of the way to prevent chafing (see Figure 6).
16. Perform a run up and check proper engine function. Check for leaks post-run up.
17. Reinstall cowl after verifying there are no leaks.
18. Make logbook entry stating that the induction hoses were replaced with P/N SC56053-001, O-rings and lock washers were changed, and CK-SB006 Rev A was complied with. The changes to weight and balance are considered negligible.
